# *Communities at Work: The Making of Çatalhöyük*

## Colour figures for Chapter 6. Integrating conservation in practice at Çatalhöyük, an inter-team perspective

*Ashley M. Lingle, Jerrod Seifert, Marek Z. Barański, Barbara Betz, Gesualdo Busacca,  
Scott Haddow, Justine Issavi, Burcu Tung, Milena Vasić & Jesse Wolfhagen*

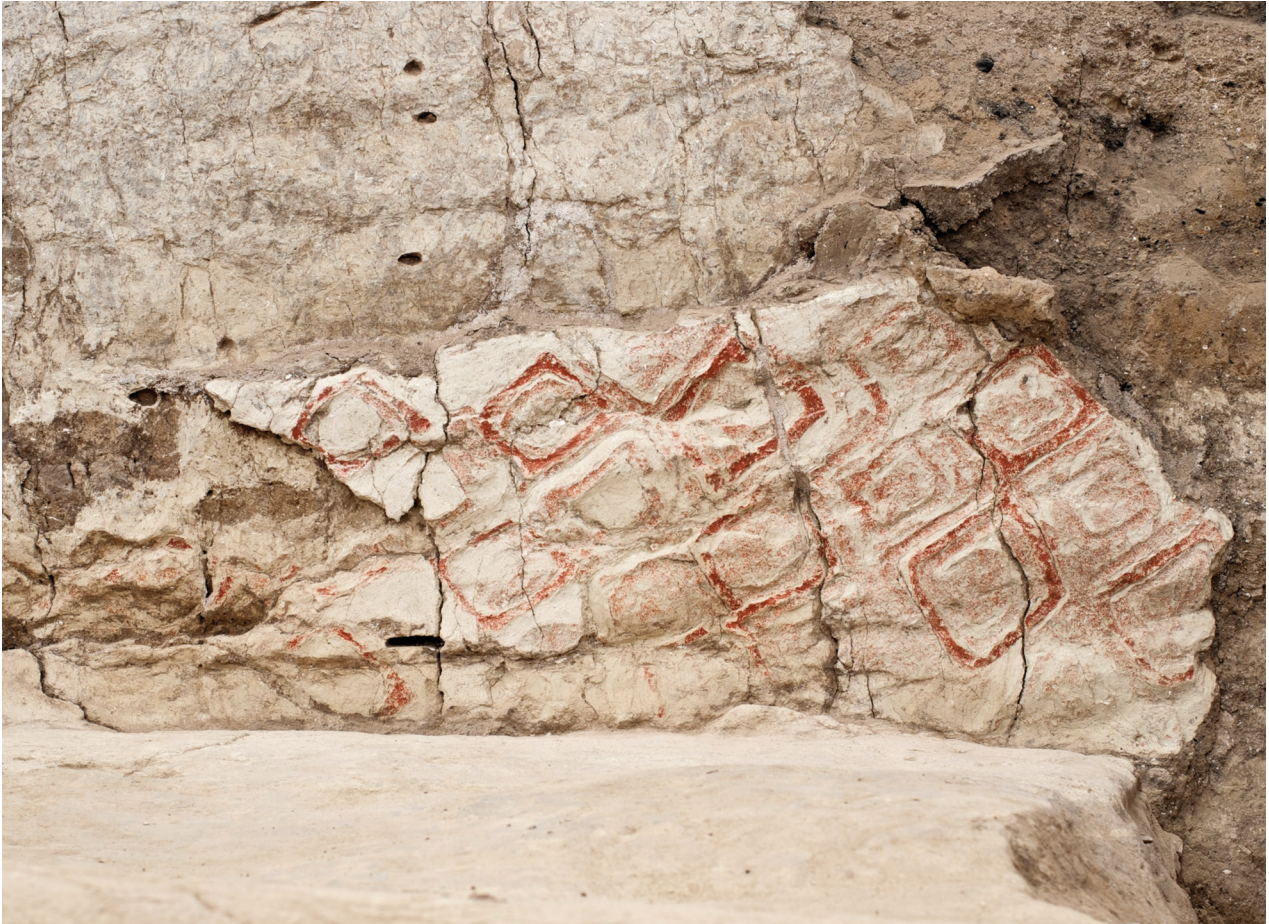
Figure 6.1. Unit (21501) in B.119. Lozenge motif in relief. Photograph taken in 2015, just before the painting was lifted by the conservation team.

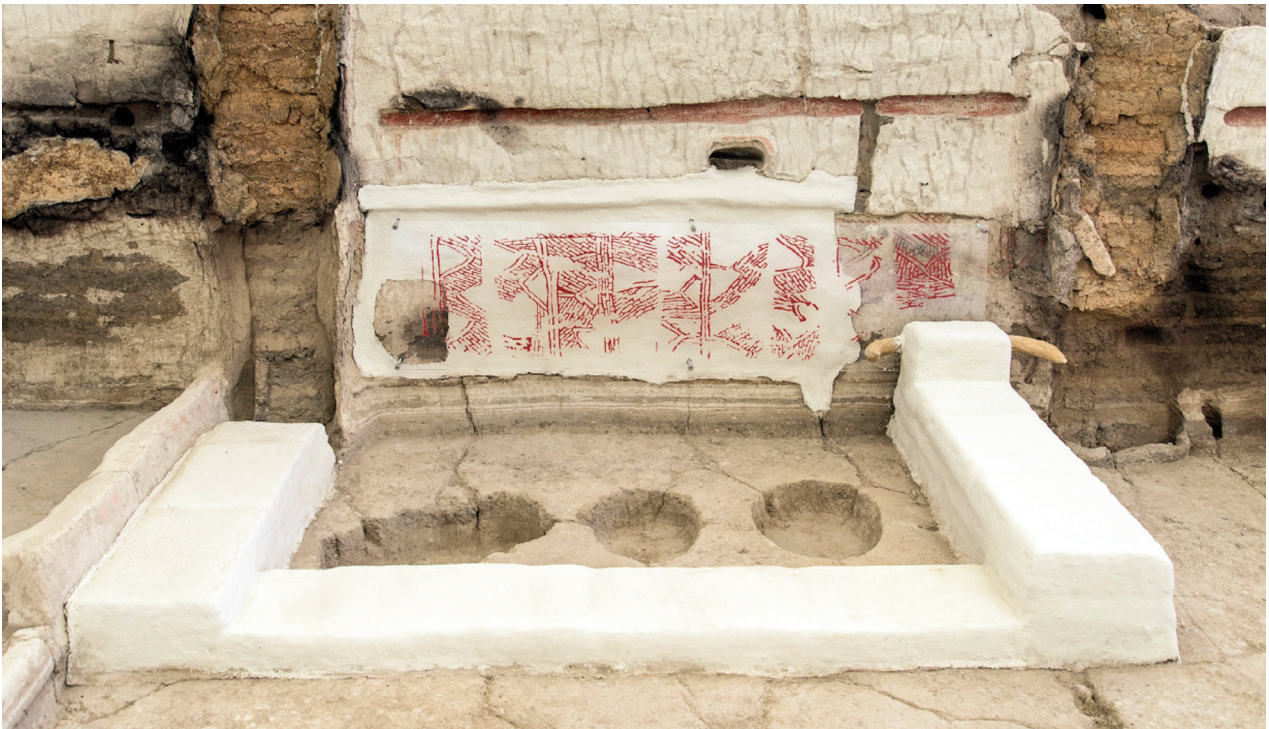
Figure 6.4. Building 80 with reconstruction and Perspex wall painting.

Can you see the red geometric wall painting towards the back of the shelter to the right? This is a reconstruction installed in 2017 on the east wall of Building 80. It is exactly where the real painting was found during the 2011 excavations. When digging, archaeologists noticed patches of red paint, and after removing layers of plaster, the pattern began to emerge. The Conservation Team took over, and to their surprise, they noticed that lines of red paint appeared on more than one layer of plaster. This might mean that, 9000 years ago, people repaired their homes just as we do today.

In 2016 it became clear that the original painting would not survive if left open to the elements. It was carefully removed to the Konya Museum. The reconstruction was then installed in its place.
