Çatalhöyük Excavations: The 2009–2017 Seasons

Colour figures for Chapter 12. Building 87 and Building 85

James Taylor

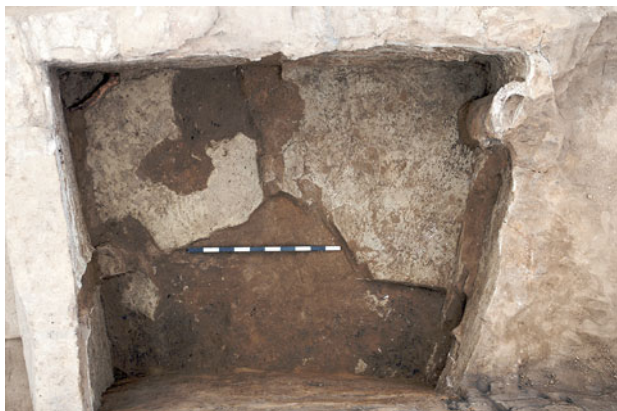
Figure 12.1. North-facing photograph of Space 374 of Building 87 as excavated, showing removed posts, scoured floors and horizontal grooves (photograph by Jason Quinlan).

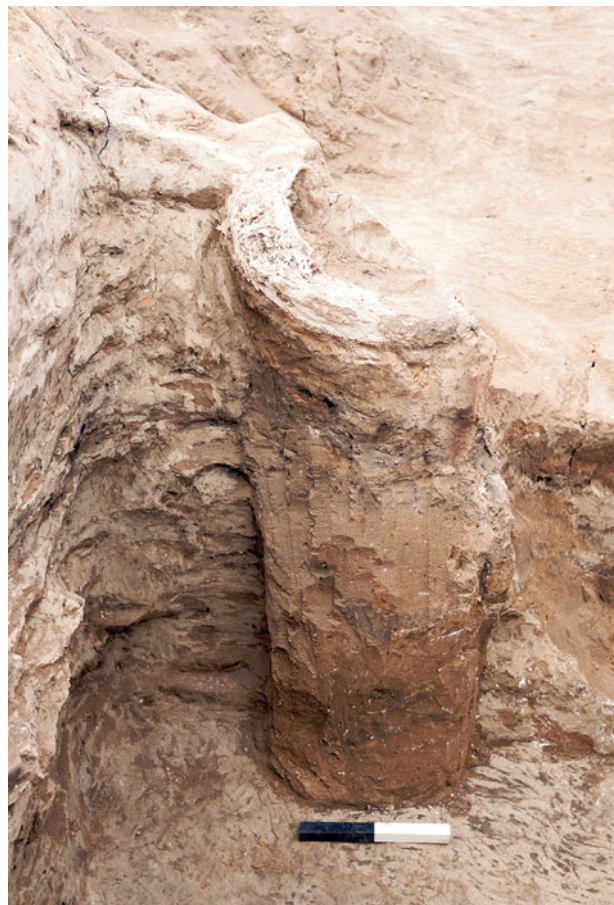
Figure 12.3. East-facing detail of engaged pillar in the northeast corner of Building 87 (photograph by Jason Quinlan).

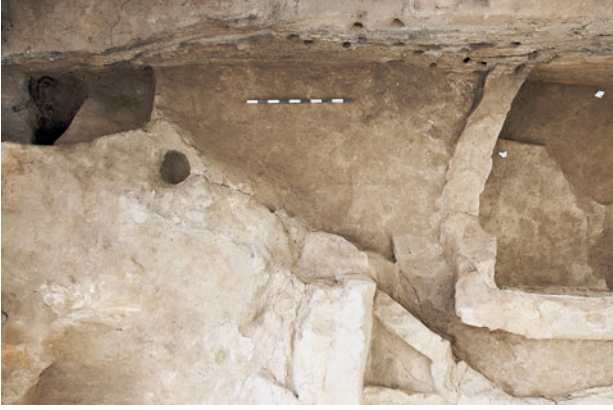
Figure 12.4. South-facing (top-down) photograph showing overview of Space 372 (photograph by Jason Quinlan).

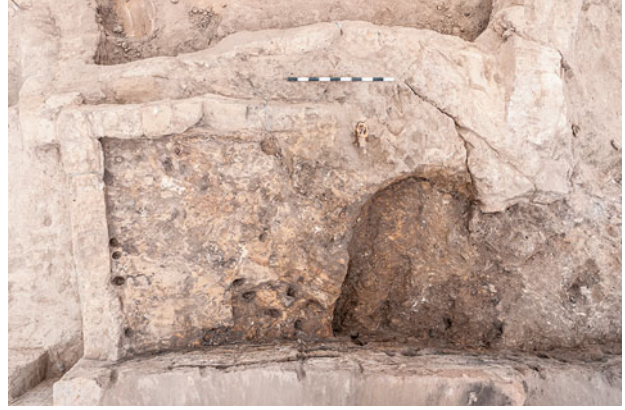
Figure 12.5. North-facing, top-down photograph of building debris and midden (18604) cut by quarry pit (18628, left) (photograph by Jason Quinlan).

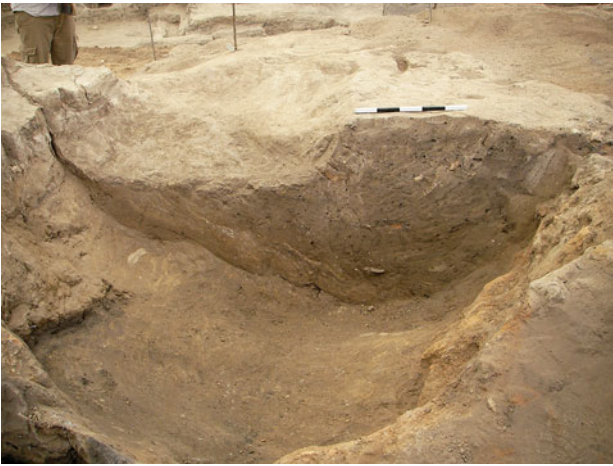
Figure 12.6. North-facing photograph showing quarry pits in the midden sequence of Space 132 (photograph by Lisa Yeomans).
