# *Çatalhöyük Excavations: The 2009–2017 Seasons*

## Colour figures for Chapter 11. Building 80

James Taylor

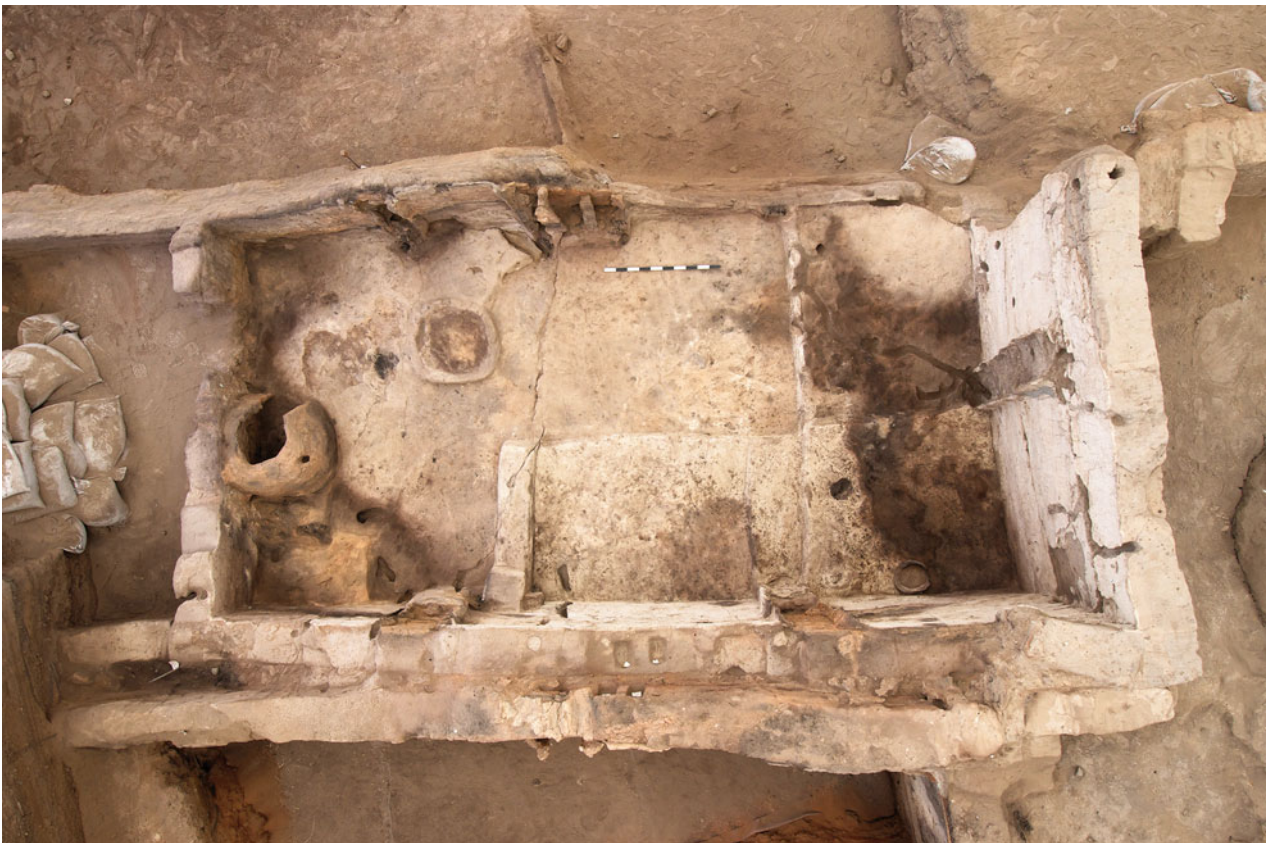
*Figure 11.1. West-facing (top down) photograph of Building 80 in its latest phase (just pre-fire/abandonment) (photograph by Jason Quinlan).*

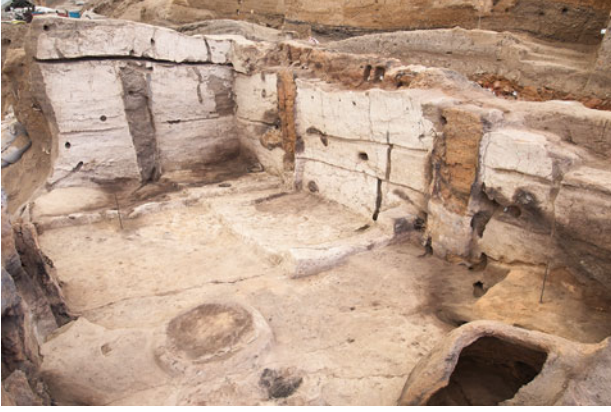
Figure 11.3. Northern end of Building 80 in its latest phase (just pre-fire/abandonment); note the height of the north wall (F.2533), which stood 2.1m high when the fire destroyed the southern part of the building (photograph by Jason Quinlan).

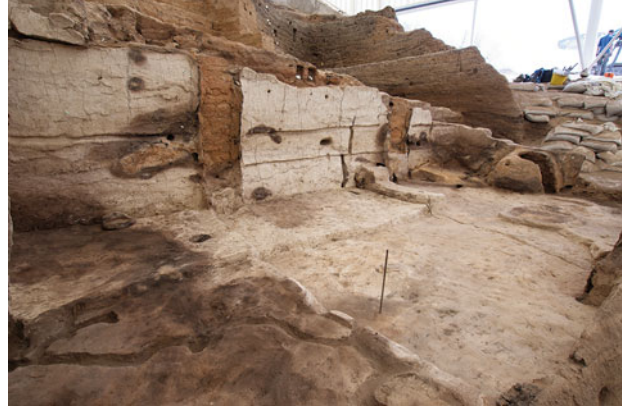
Figure 11.4. Southern end of Building 80 in its latest phase (photograph by Jason Quinlan).

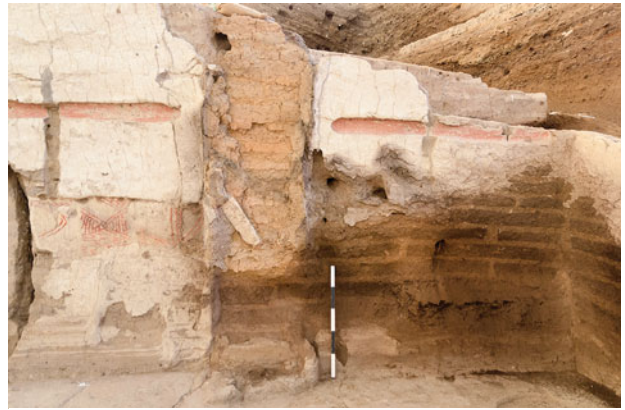
Figure 11.5. East-facing photograph of wall F.5014, showing engaged pillars and the linear inset band (18985) (photograph by Thaer Yartah).

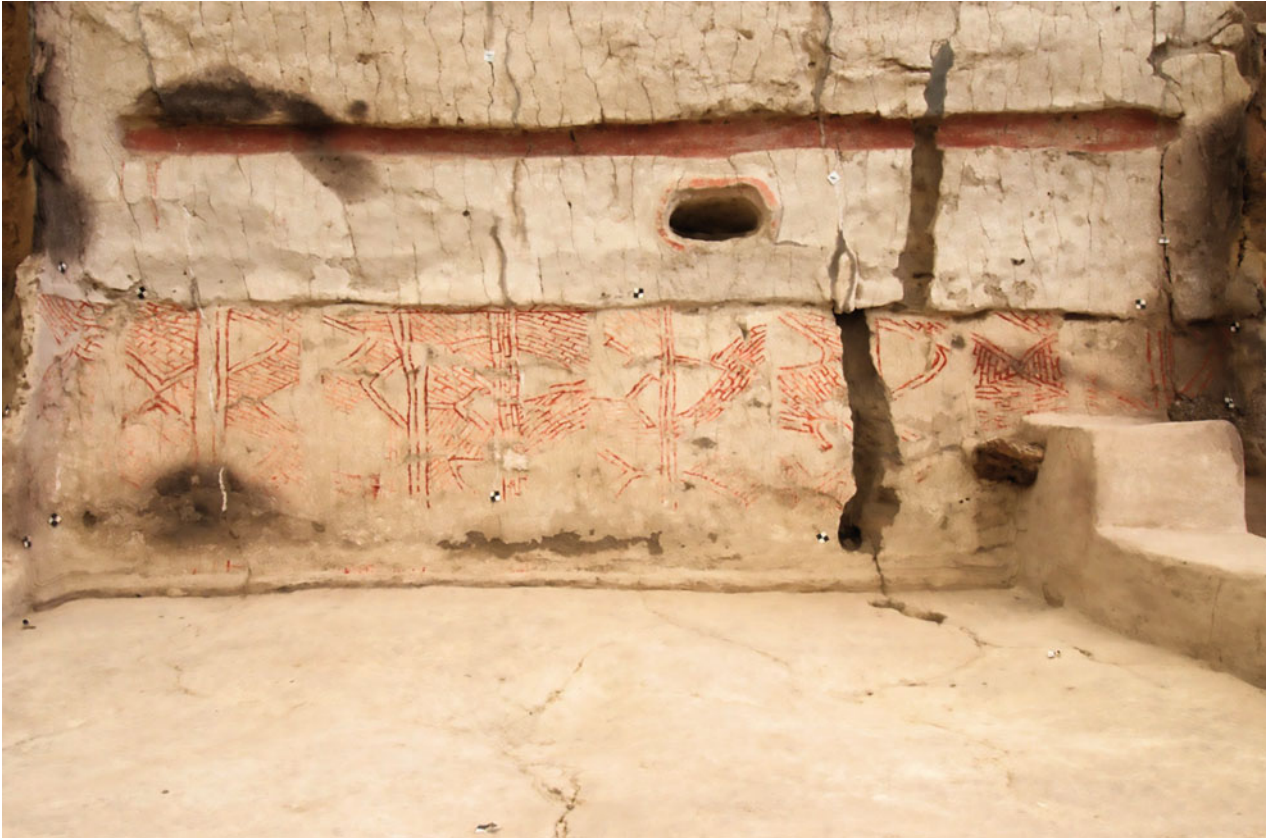
Figure 11.6. East-facing photograph showing the painting (18918) on the east wall of Building 80 (F.5014); note the small niche with a red border in the centre-right of the upper panel, below the linear inset band (photograph by Jason Quinlan).

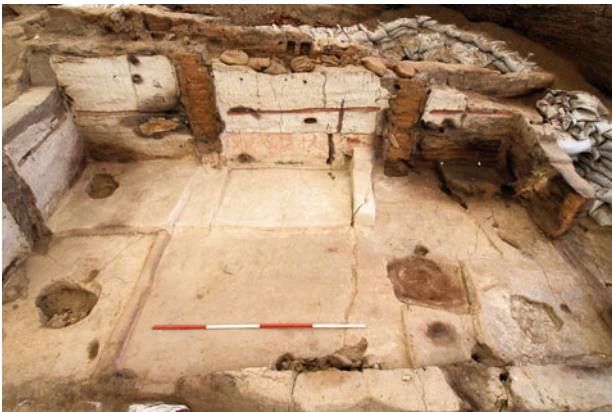
Figure 11.7. East-facing photograph of Space 135, showing early features in the building including engaged posts against the eastern wall of Space 135 (F.3428 and 3429 respectively) (photograph by Jason Quinlan).

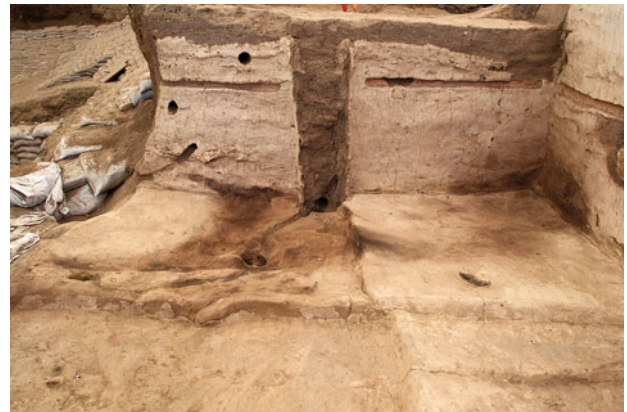
Figure 11.8. North-facing photograph of engaged pillar F.3422 against the northern wall of Space 135 (photograph by Justine Issavi).

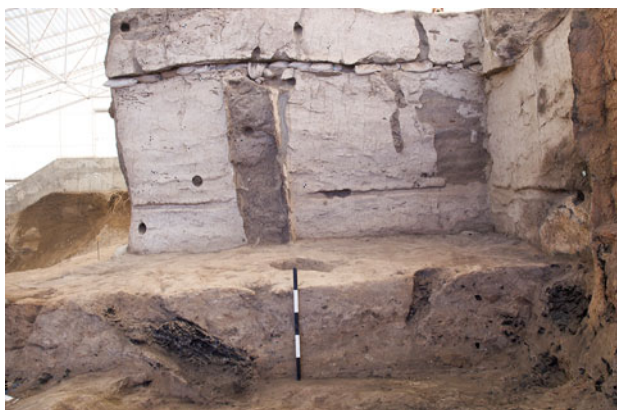
Figure 11.9. North-facing photograph of the same engaged pillar against the northern wall of Space 135 (F.2533), prior to the removal of the upper part of the wall in 2013; note the relationship between the top of the post scar and the upper section of wall, divided by a horizontal timber slot running along the internal face of the wall (photograph Çatalhöyük Research Project).

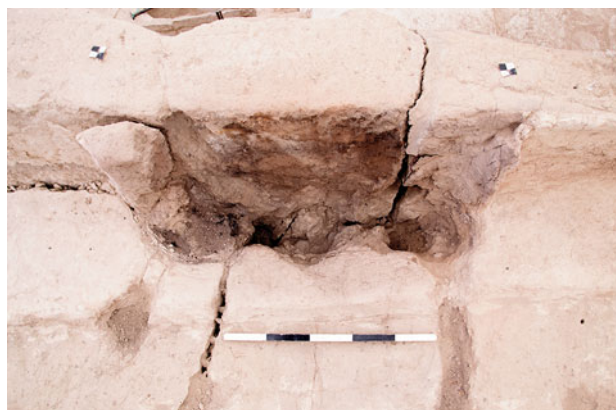
Figure 11.10. West-facing photograph showing triple post installation (F.3433) against the west wall of Space 135 and associated kerb (photograph by Katie Campbell).

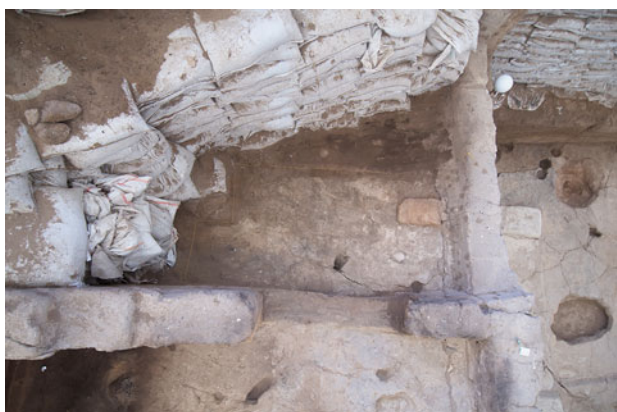
Figure 11.11. South-facing (top down) overview showing accessible limits of Space 373 (photograph by Jason Quinlan).

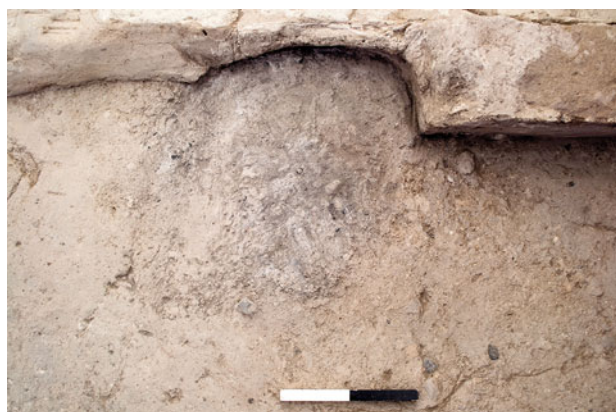
Figure 11.12. North-facing photograph showing fire spot (21235/21272) (photograph by Thaer Yartah).

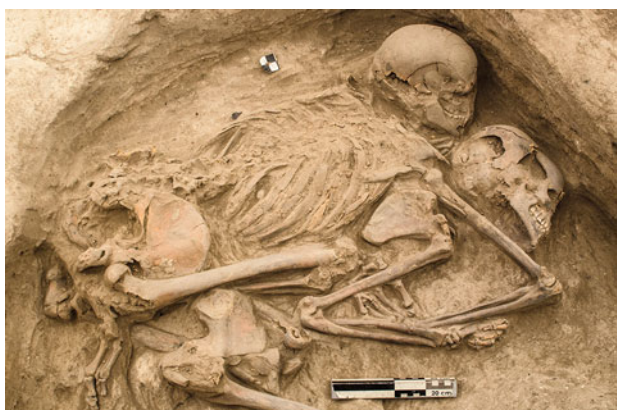
Figure 11.14. South-facing photograph showing burial F.7418 (photograph by Jason Quinlan).

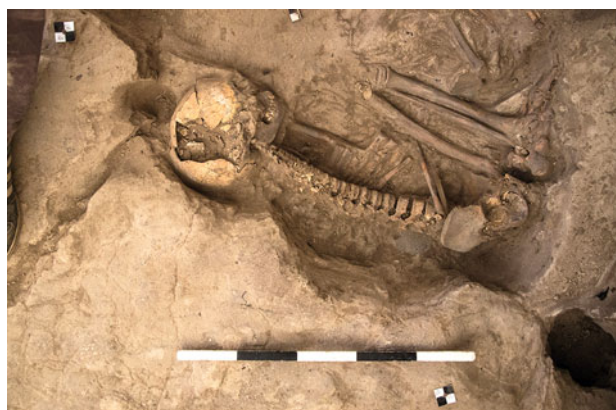
Figure 11.15. North-facing photograph showing burial F.7420 (photograph by Jarrod Seifert).

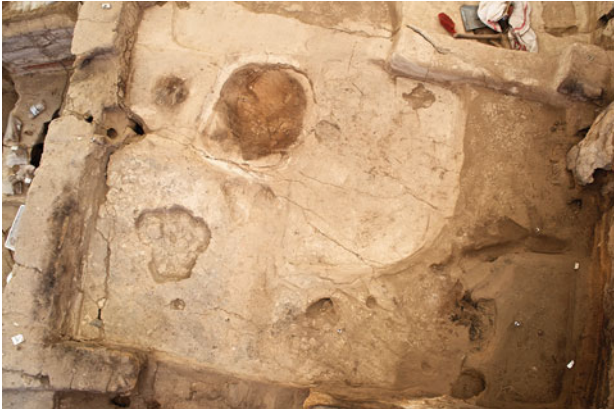
Figure 11.16. North-facing overview of southern part of Space 135, showing re-build of structured hearth F.7402 and construction of new platform F.7423 (photograph by Kate Rose).

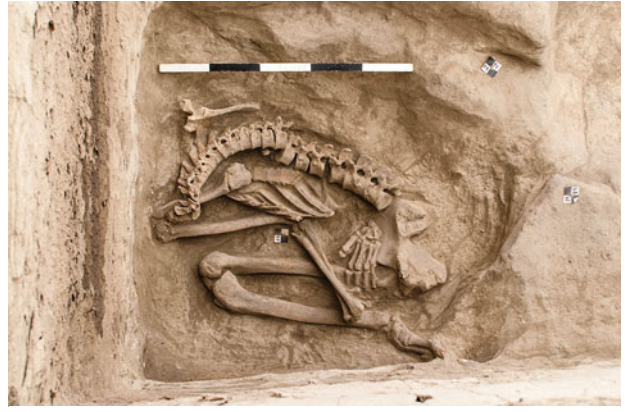
Figure 11.18. South-facing photograph of the burial F.7427 in the northeast corner of the northeast platform of B.80 (photograph by Jason Quinlan).

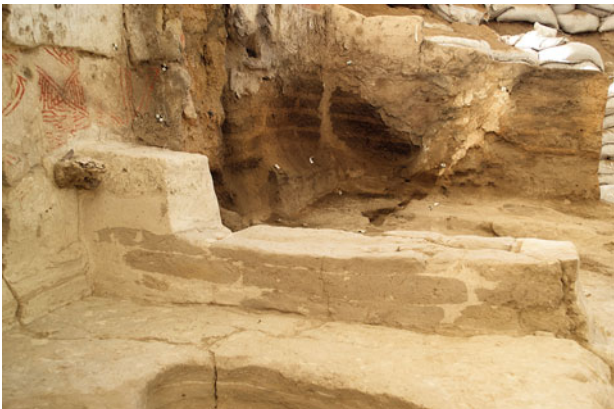
Figure 11.19. Southeast-facing photograph showing bucranium set into bench F.7415 and the brick core (22436) of the original bench structure (photograph by Mateusz Dembowski).

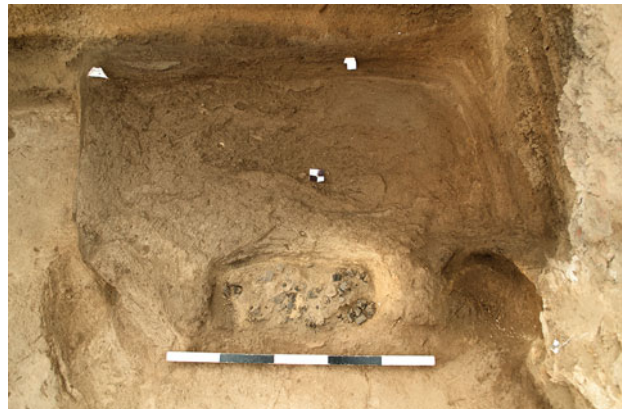
Figure 11.20. East-facing photograph detailing the in situ remains of the burnt wooden ladder (F.7425) (photograph by Kate Rose).

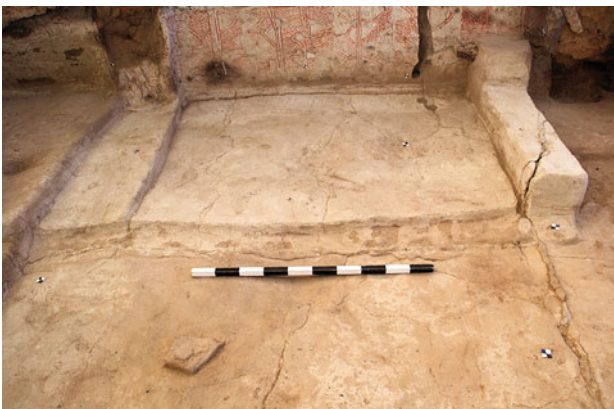
Figure 11.21. East-facing photograph showing embedded quern installation (21767.x2) in situ in the central floor of Space 135 (photograph by Mateusz Dembowski).

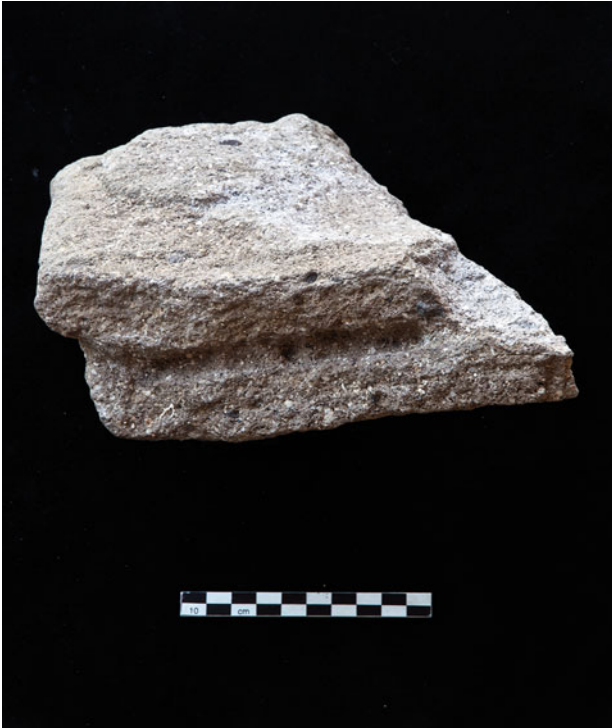
Figure 11.22. Quern (21767.x2) (photograph by Jason Quinlan).

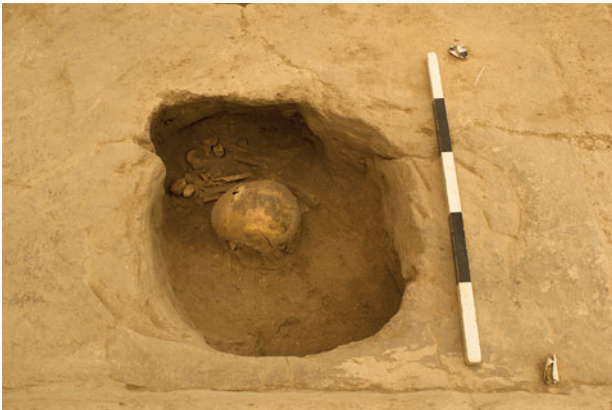
Figure 11.25. South-facing photograph showing burial F.7407 (photograph by Scott Haddow).

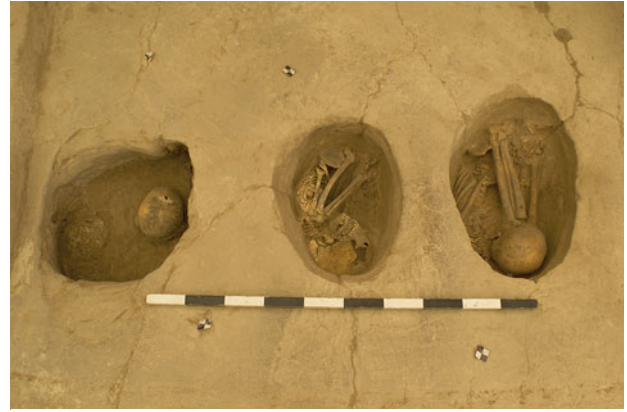
Figure 11.24. East-facing photograph showing three primary child burials in the east-central platform (left to right: F.7407, F.7408 and F.7409) (photograph by Scott Haddow).

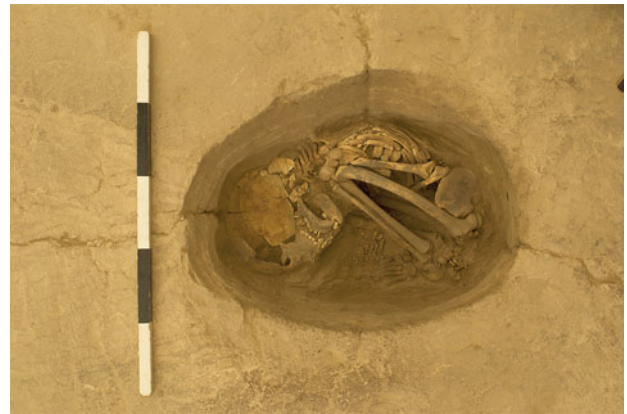
Figure 11.26. North-facing photograph showing burial F.7408 (photograph by Scott Haddow).

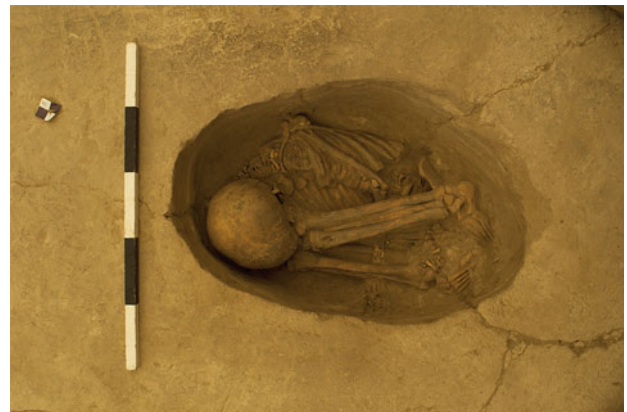
Figure 11.27. North-facing photograph showing burial F.7409 (photograph by Scott Haddow).

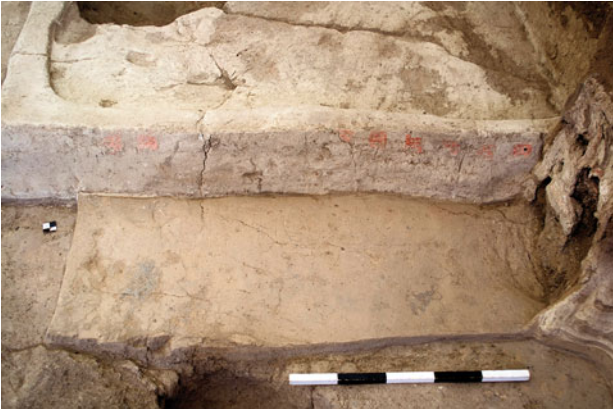
Figure 11.28. North-facing photograph showing bench feature F.7410 (photograph by Thaer Yartah).

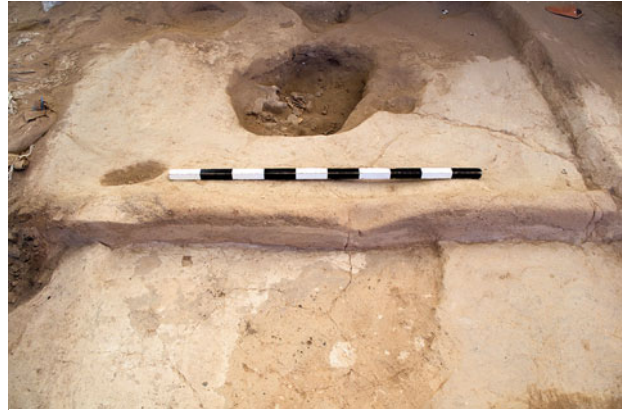
Figure 11.29. North-facing photograph of clay partition (21781) (photograph by Halle Payne).

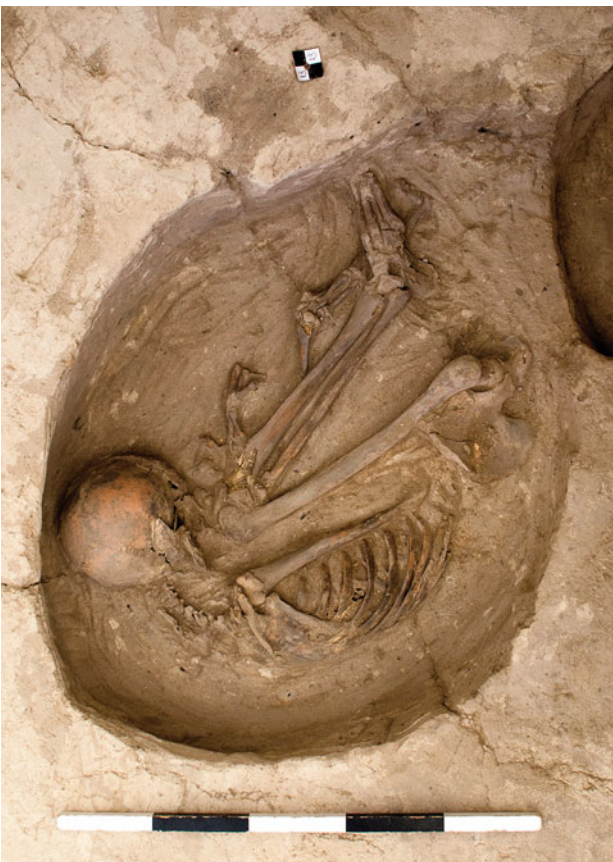
Figure 11.30. North-facing photograph of burial F.7422 (photograph by Jason Quinlan).

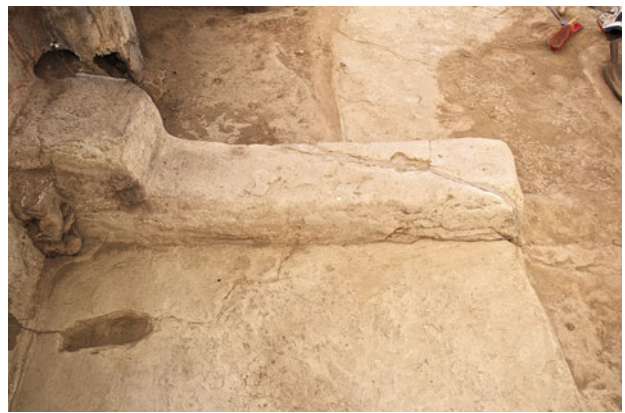
Figure 11.31. South-facing photograph of platform F.7401 and its relationship with bench structure F.3439 (photograph by Megan Ridsdale).

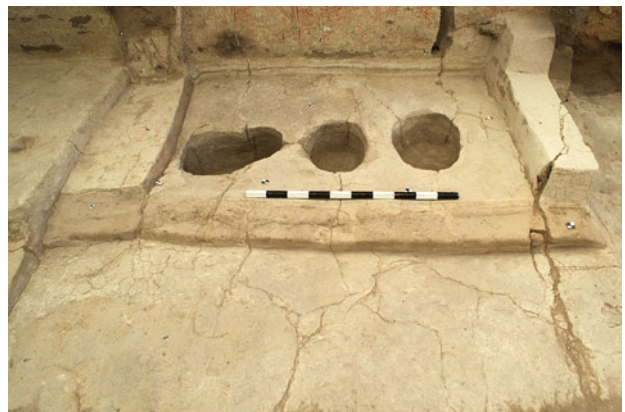
Figure 11.33. East-facing photograph of mudbrick platform modification (22416/22417) (photograph by Mateusz Dembowiak).

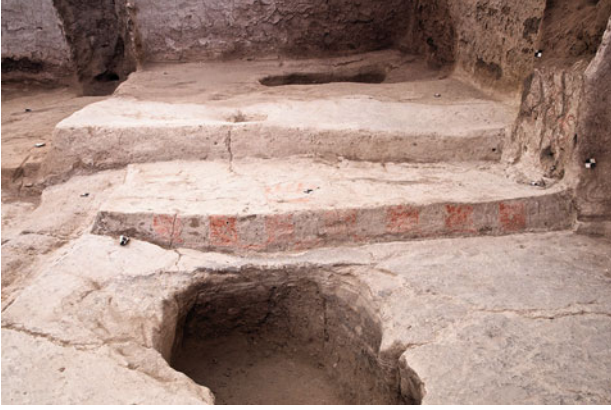
Figure 11.34. North-facing photograph showing red stripes found upon the plaster (21789) on bench structure, F.7410 next to the central platform in Space 135 (photograph by Jason Quinlan).

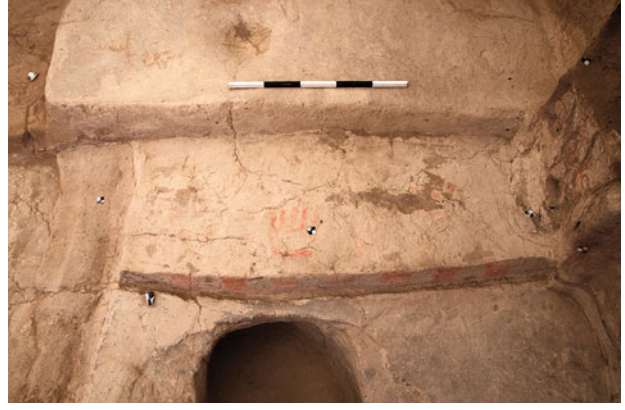
Figure 11.35. North-facing photograph showing red handprint on top surface of bench F.3439 (21789) (photograph by Jason Quinlan).

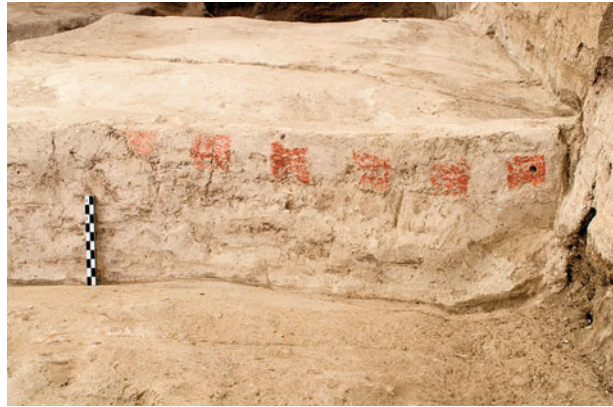
Figure 11.36. North-facing photograph of 'chequer-board' red painting discovered on the edge of platform F.7410 (photograph by Jason Quinlan).

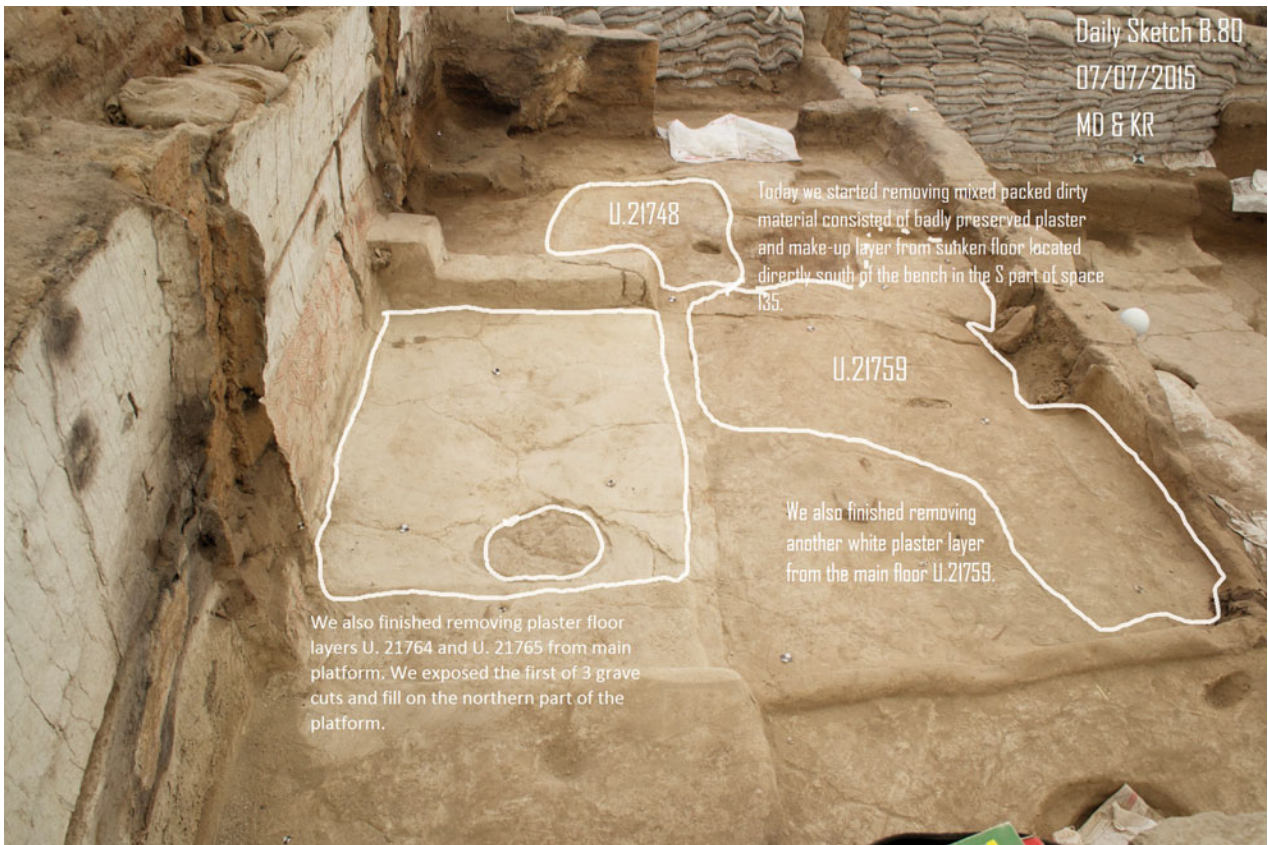
Figure 11.37. Daily sketch by Kate Rose showing floors (21748), (21759), (21764) and (21765) in Building 80.

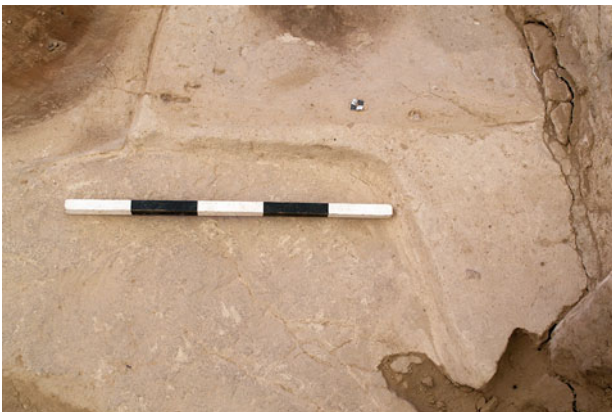
Figure 11.38. Northeast-facing photograph of moulded-clay structure (20088) (photograph by Kate Rose).

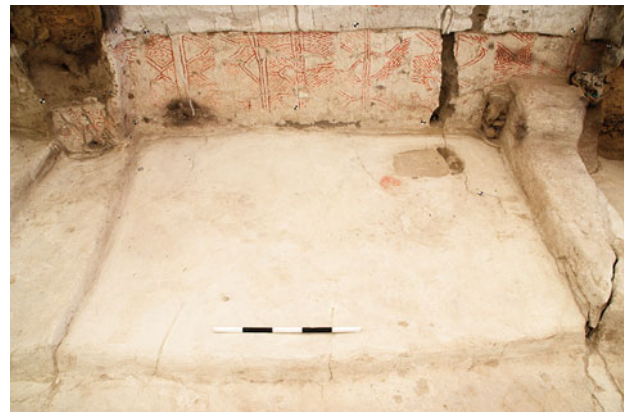
Figure 11.41. East-facing photograph of the red pigment 'spill' (20079) in context on the surface that seals the burial sequence (18989) of the east-central platform (photograph by Jason Quinlan).

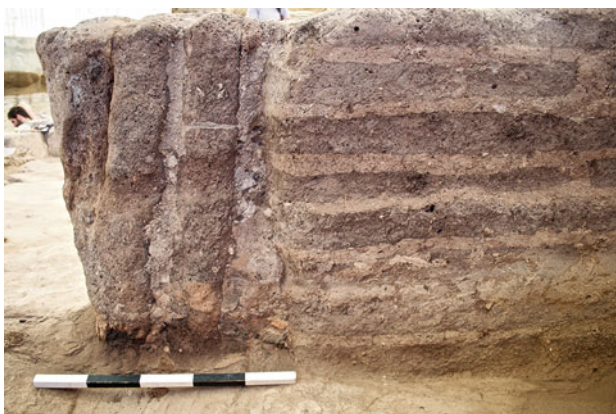
Figure 11.42. North-facing photograph showing southern face of partition wall extension F.7403 with vertical bricks (photograph by Megan Ridsdale).

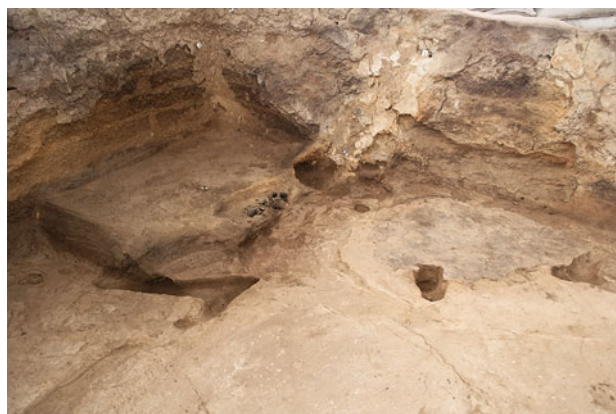
Figure 11.44. Southeast-facing photograph of the southern area of Space 135, showing the oven base (F.5041) and associated ladder platform, with charred in situ wood remains and ladder scar up the southern partition wall (photograph by Mateusz Dembowskiak).

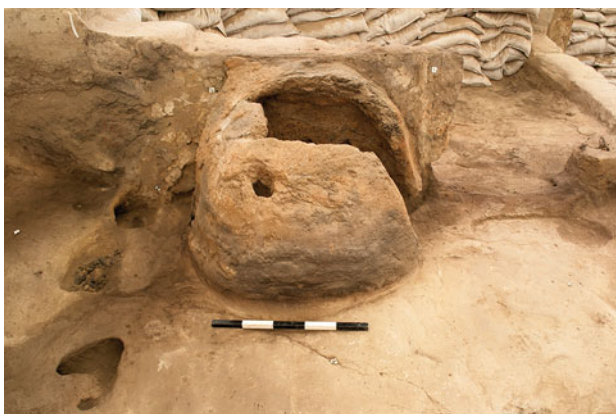
Figure 11.45. South-facing photograph showing almost complete oven F.5041 (photograph by Justine Issavi).

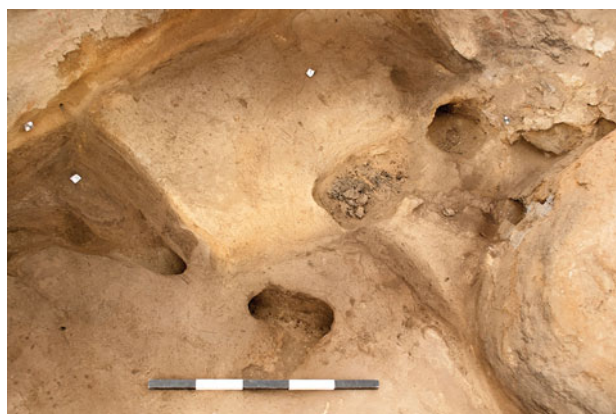
Figure 11.46. Southeast-facing photograph showing compound surface (18976) (photograph by Jason Quinlan).

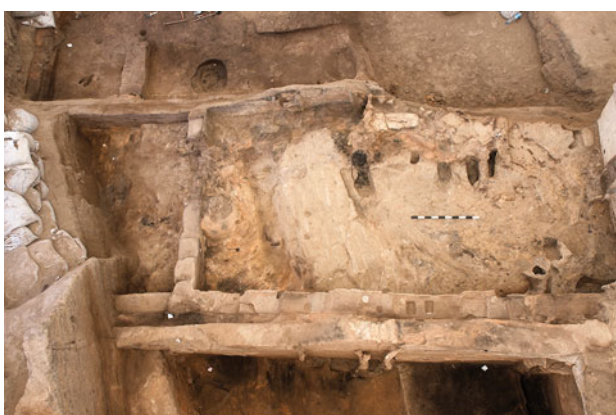
Figure 11.47. Top down (west-facing) photograph showing overview of destruction and abandonment deposits in Building 80 (with Building 79 situated to the east, bottom of image) (photograph by Jason Quinlan).

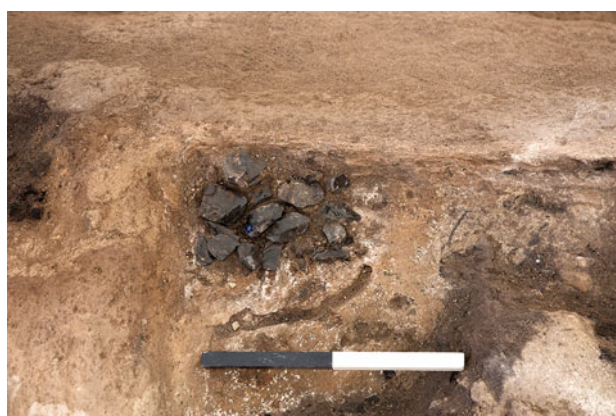
Figure 11.48. West-facing photograph showing the obsidian abandonment cluster on the northwest platform of Space 135 (18944) (photograph by Jason Quinlan).

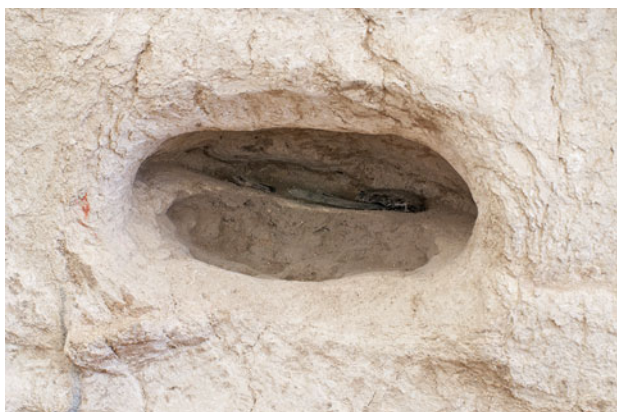
Figure 11.49. East-facing photograph showing the obsidian abandonment cluster in niche F.3434 (18932) (photograph by Jason Quinlan).

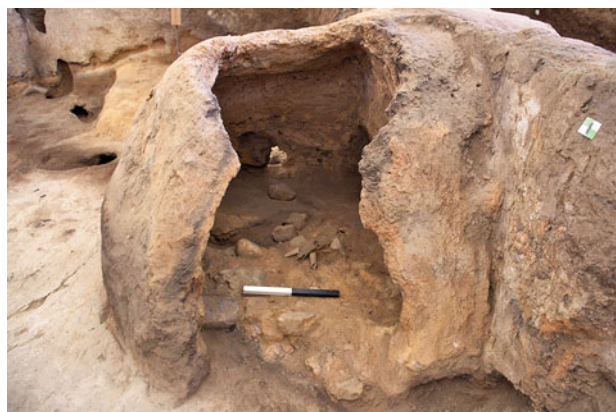
Figure 11.50. East-facing photograph showing the ground stone abandonment cluster on the collapsed roof of oven F.5041 (18955) (photograph by Roddy Regan).

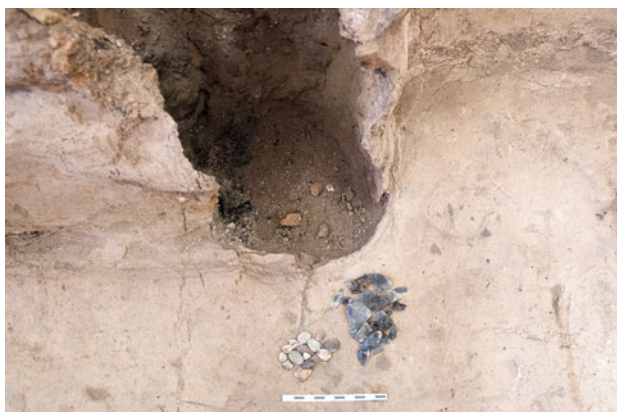
Figure 11.51. West-facing photograph showing the obsidian and stone cluster associated with the abandonment of F.3433 (18965) (photograph by Roddy Regan).

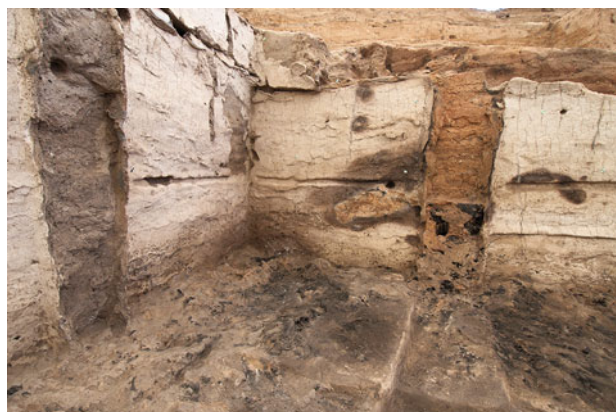
Figure 11.52. Northeast-facing photograph showing charcoal-rich deposit (18948) close to the floor, which could be the remains of a wooden structure (photograph by Jason Quinlan).

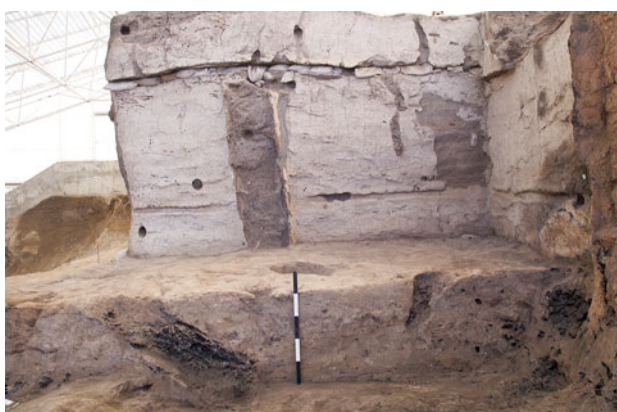
Figure 11.53. North-facing photograph showing elements of charred timber (18538), (18585) and (18586) in section through the backfill of Space 135 (photograph by Roddy Regan).

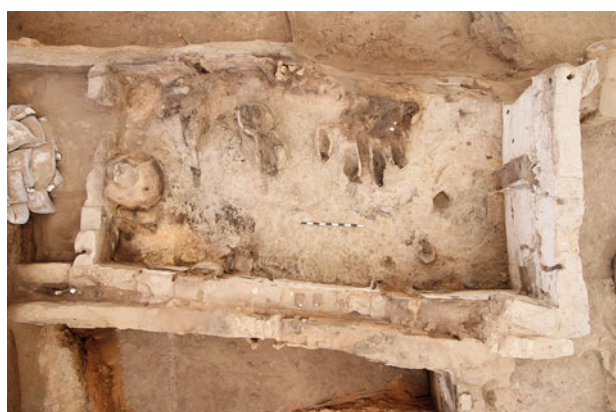
Figure 11.54. West-facing downward overview of backfill clearly showing rows of charred east-west oriented timber remains through the fill deposits (photograph by Jason Quinlan).

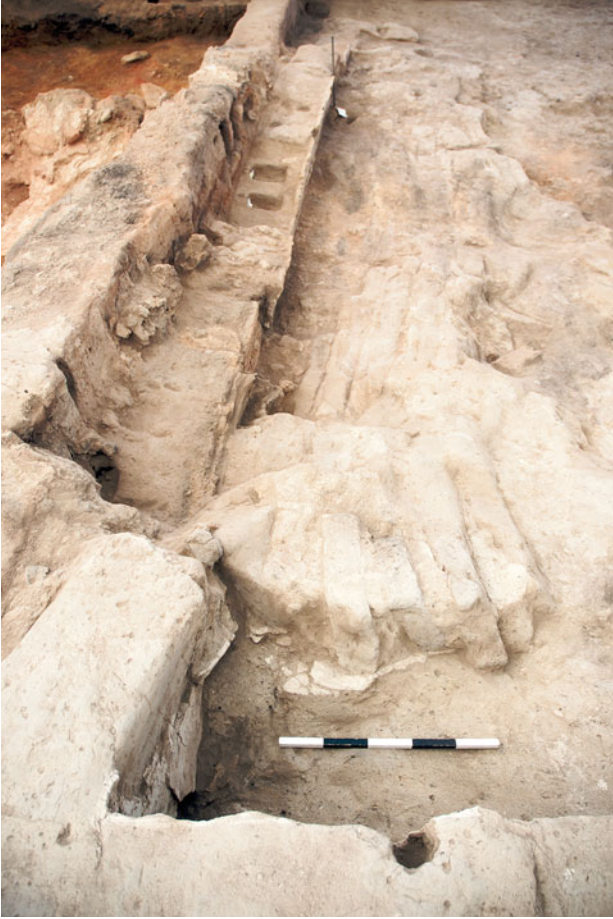
*Figure 11.55. South-facing photograph showing detail of sheet-collapsed wall along the eastern part of the backfill, probably associated with the upper part of the eastern wall (photograph by Jason Quinlan).*

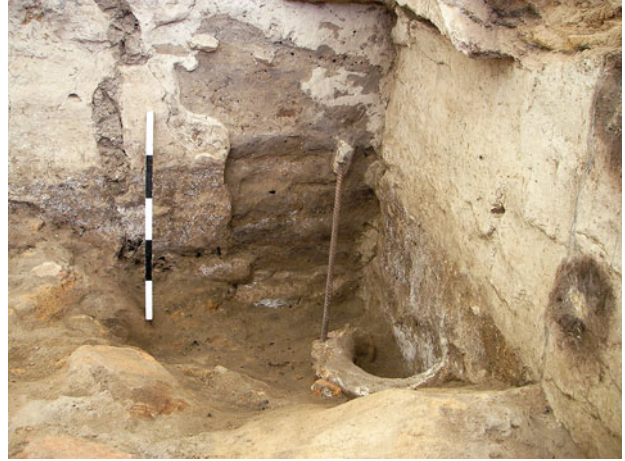
*Figure 11.56. North-facing photograph showing possible installation retrieval pit (18563) through the backfill in the northeast corner of Space 135 (photograph by Roddy Regan).*
