# *Çatalhöyük Excavations: The 2009–2017 Seasons*

## Supplementary material to Chapter 17. Building 118 and Space 583

James Taylor

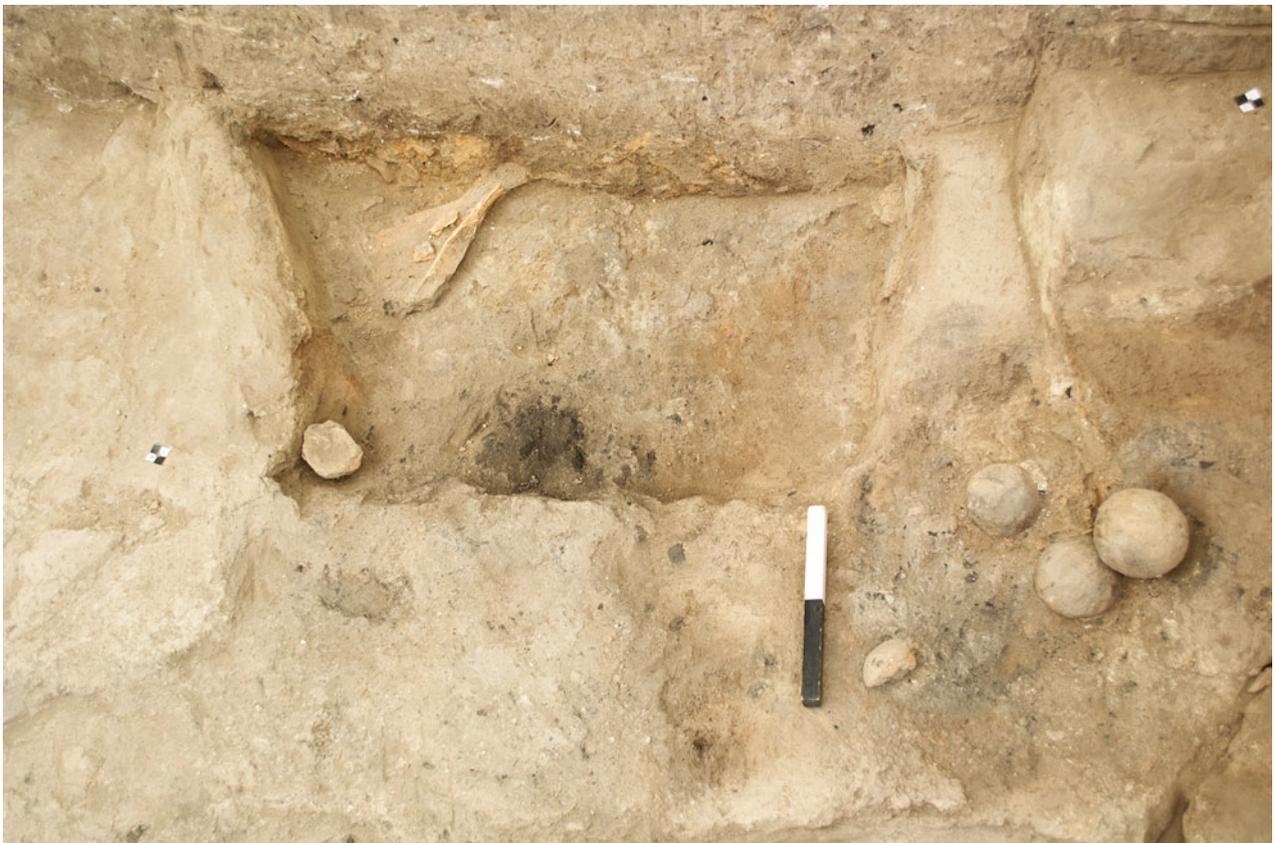
*Figure S17.1. South-facing photograph showing detail of clay ball cluster (30630) against oven (F.7202), and dirty floors (30652) to the north (photograph by Onur Yüksel).*

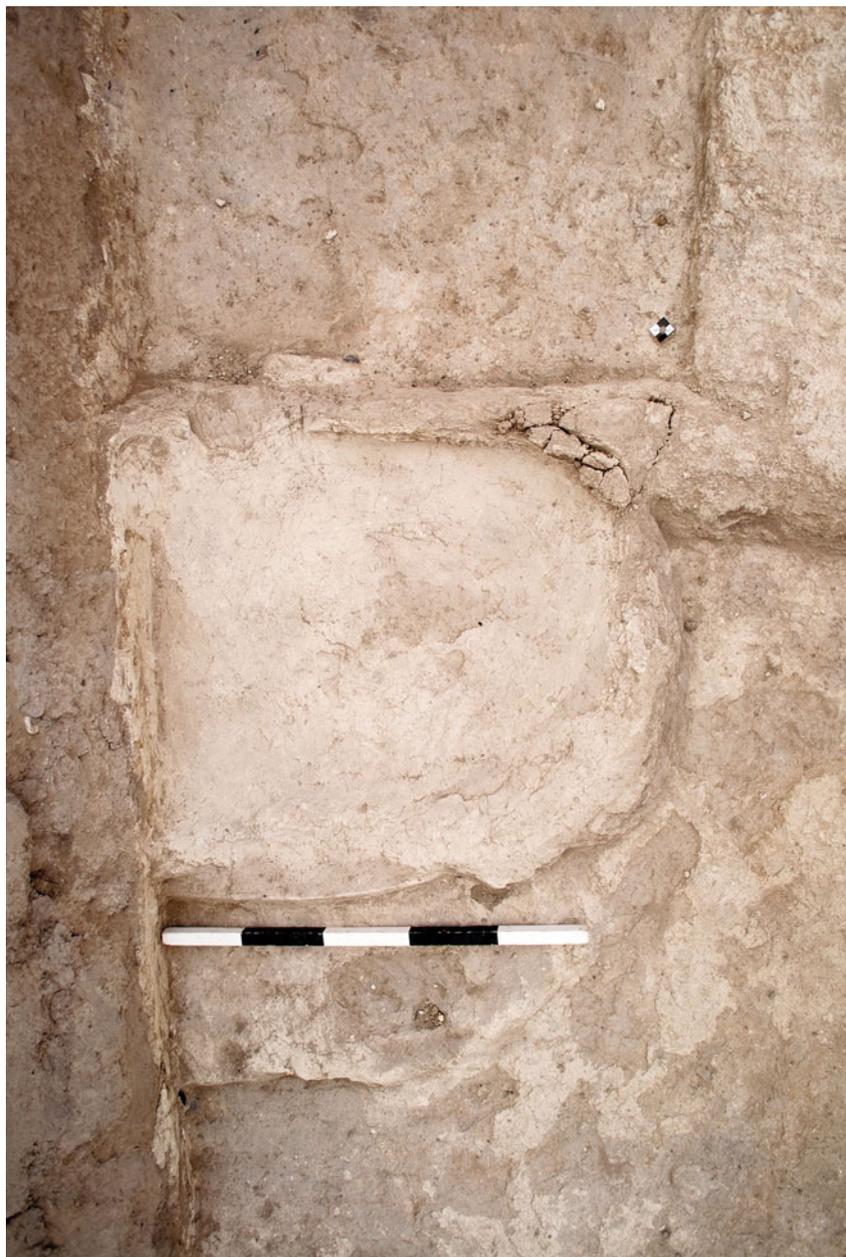
*Figure S17.2. West-facing photograph showing detail of bin F.7201 (photograph by Onur Yüksel).*

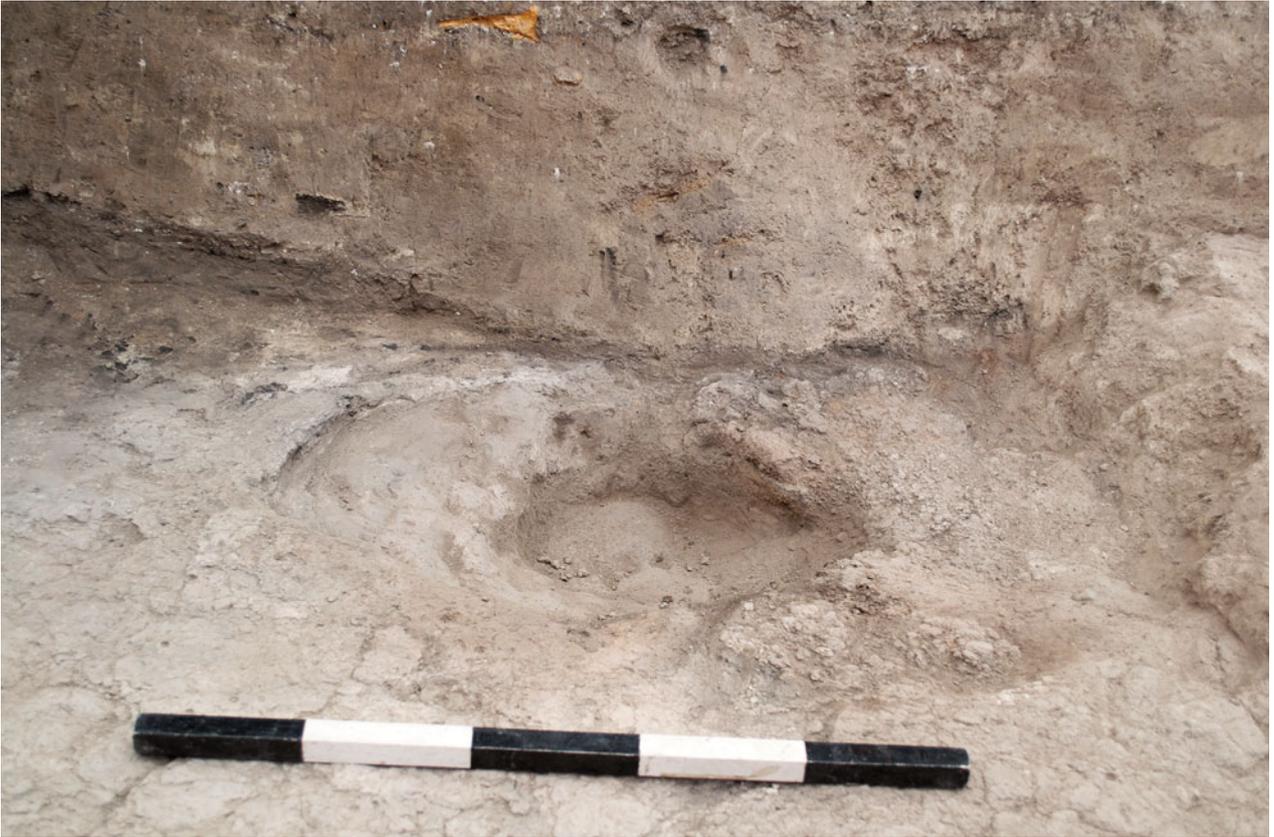
Figure S17.3. South-facing photograph showing detail of hearth F.7205 (photograph by Onur Yüksel).

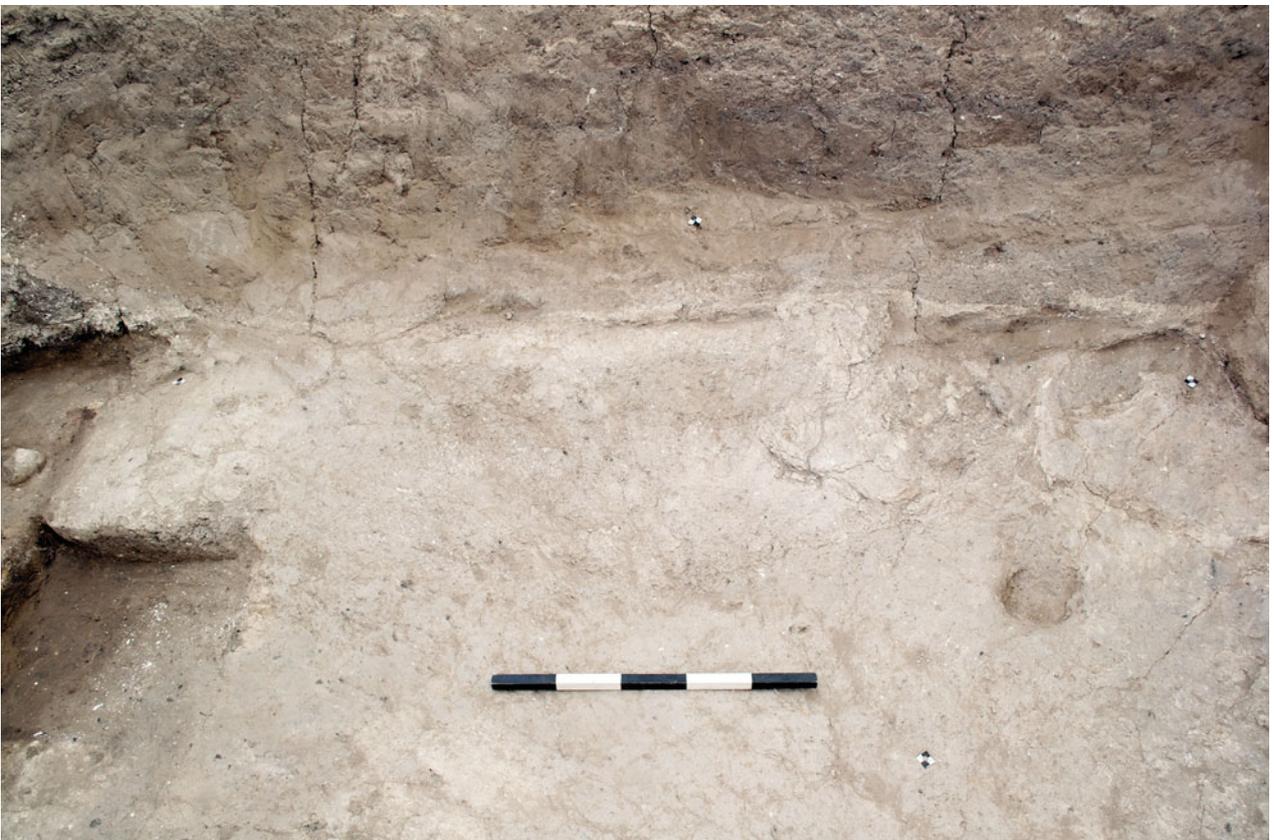
Figure S17.4. East-facing photograph showing ramp F.7204 and bench F.7212 (photograph by Onur Yüksel).

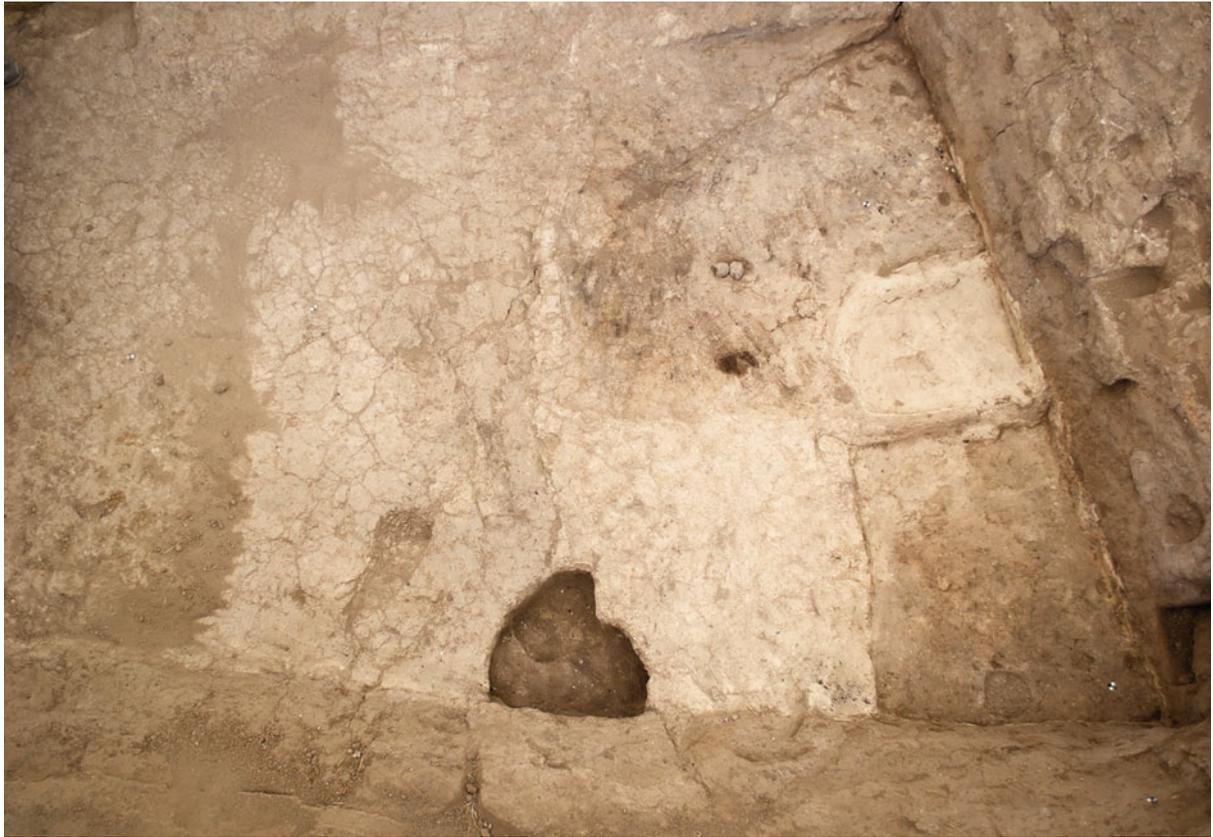
*Figure S17.5. South-facing photograph of the west end of B.118 showing post retrieval pit (30612) (photograph by Matteo Pilati).*

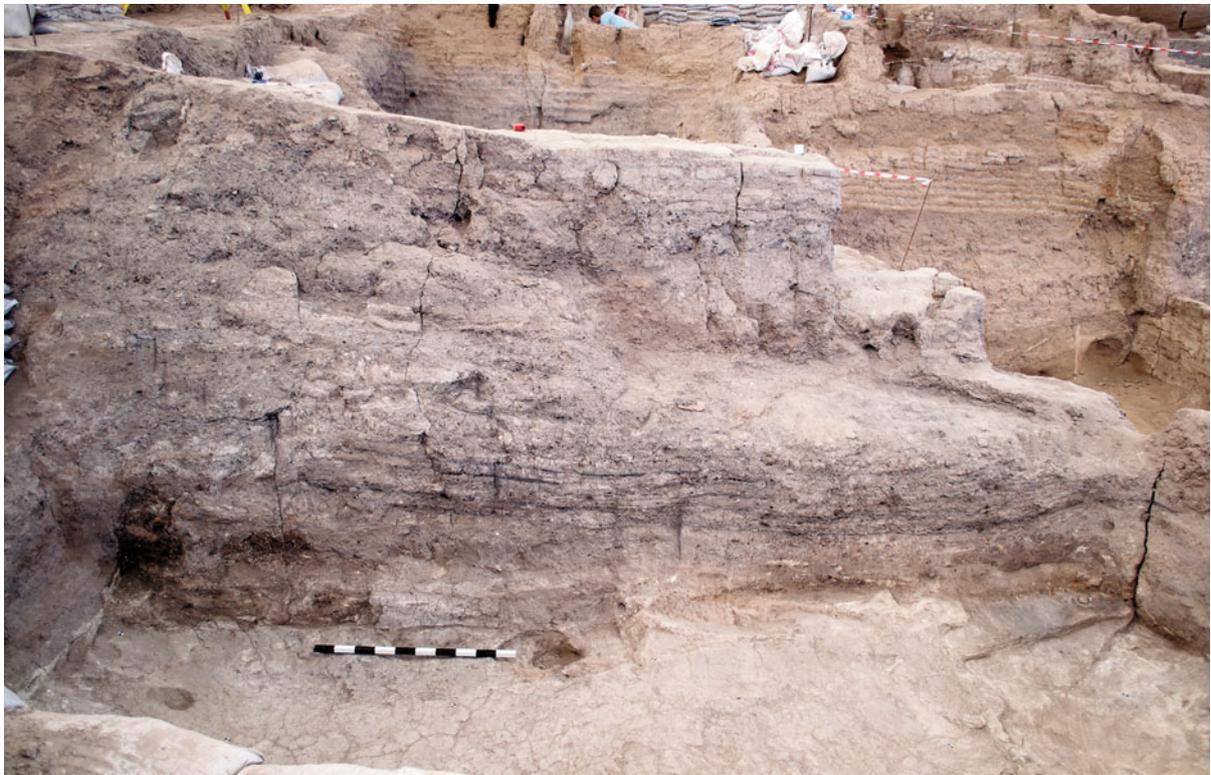
*Figure S17.6. South-facing photograph showing the section through the complete midden deposits of Sp.583 and superjacent spaces (photograph by James Taylor).*
