Çatalhöyük Excavations: The 2009–2017 Seasons

Edited by
Ian Hodder

Colour figures for Chapter 15. Building 96

James Taylor

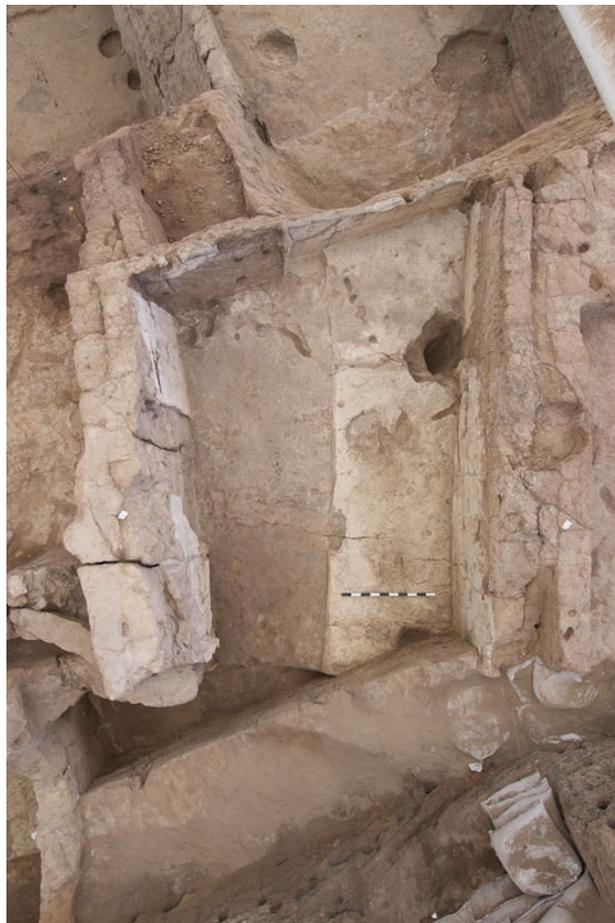
Figure 15.1. North-facing photograph showing overview of Building 96, Sp.370 (photograph by Jason Quinlan).

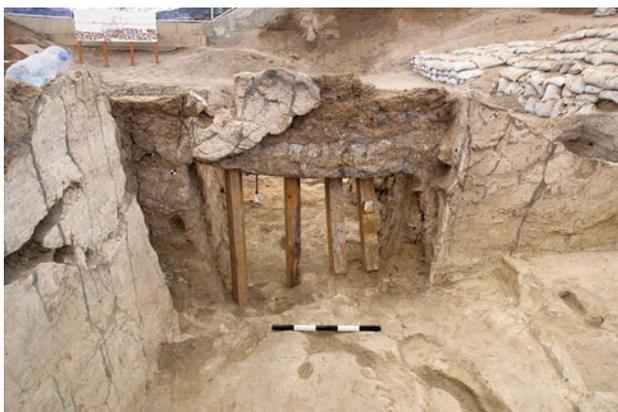
Figure 15.3. North-facing photograph showing northern end of Building 96, including the intact crawl-hole and associated post holes (photograph by Çatalhöyük Research Project).

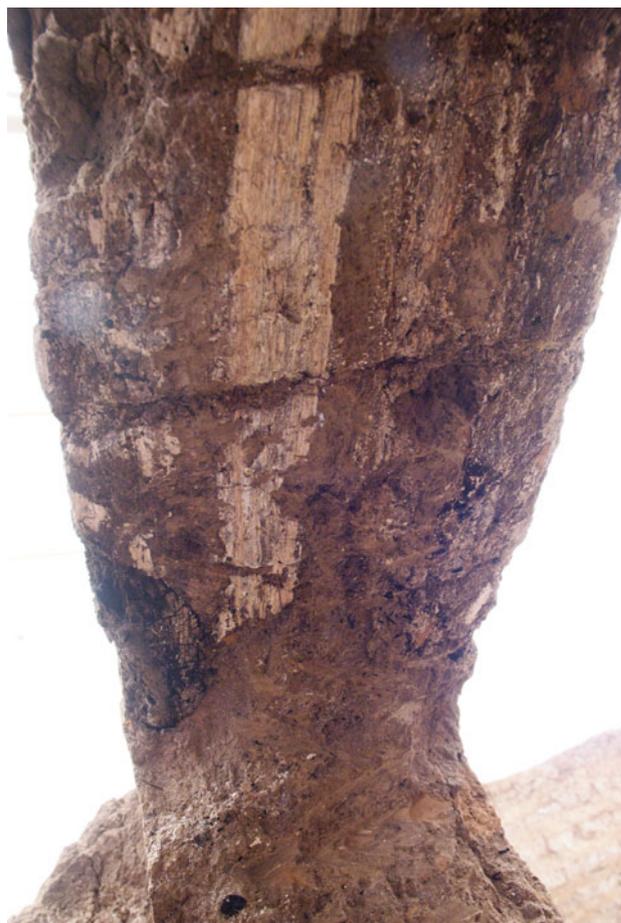
Figure 15.6. Upward (west)-facing photograph showing internal detail of the Building 96 crawl-hole (F.3504) (photograph Çatalhöyük Research Project).

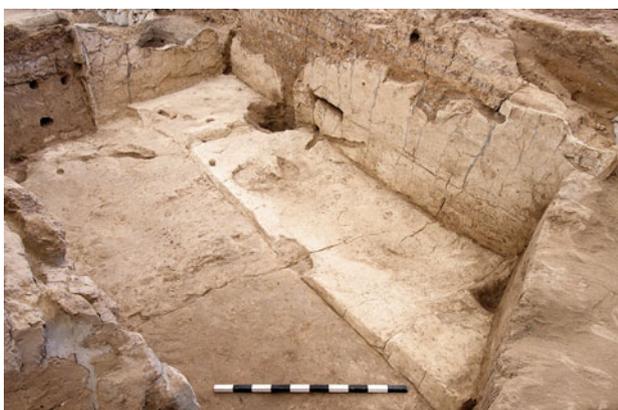
Figure 15.4. Northeast-facing photograph showing the eastern and northeastern platforms, F.3508 and F.3507 respectively (photograph by Jason Quinlan).

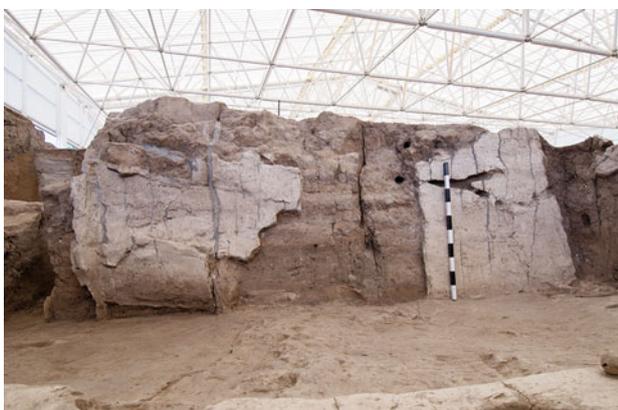
Figure 15.5. West-facing photograph showing detail of the break in the plaster on the internal face of the western wall (F.4090) (photograph by Jason Quinlan).

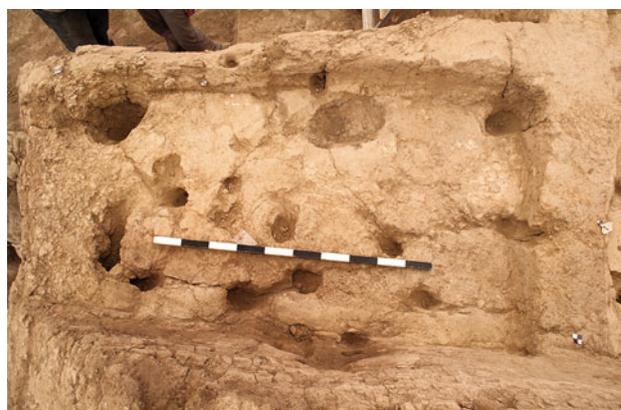
Figure 15.7. East-facing photograph showing the earliest surface in Space 444 (20890) (photograph by Maciej Chyleński).

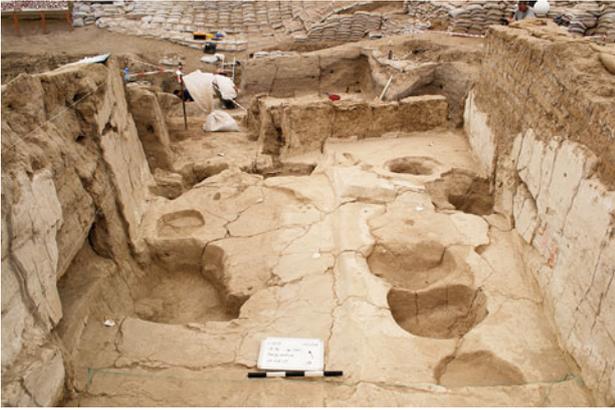
Figure 15.8. North-facing daily sketch photograph of earliest excavated plaster floors in Space 370 ((20855), (20857) and (20866)) (photograph by Johanna Bergqvist).

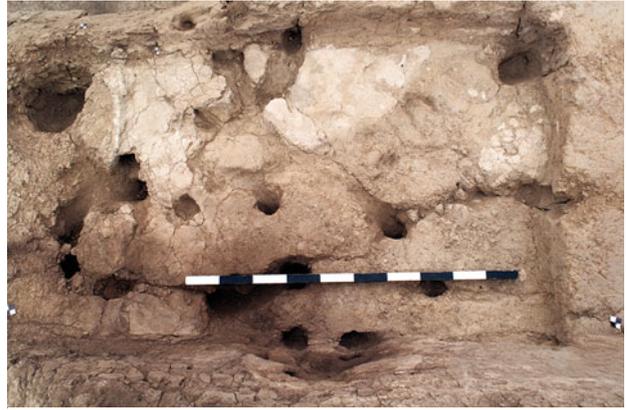
Figure 15.9. East-facing photograph of Space 444 with remnant bins (F.8000 and F.8001) visible at north end (photograph, by Maciej Chyleński).

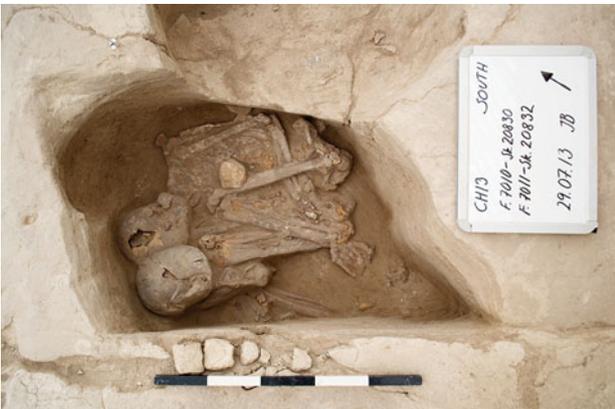
Figure 15.12. West-facing photograph of burials F.7010 and F.7011 (photograph by Johanna Bergqvist).

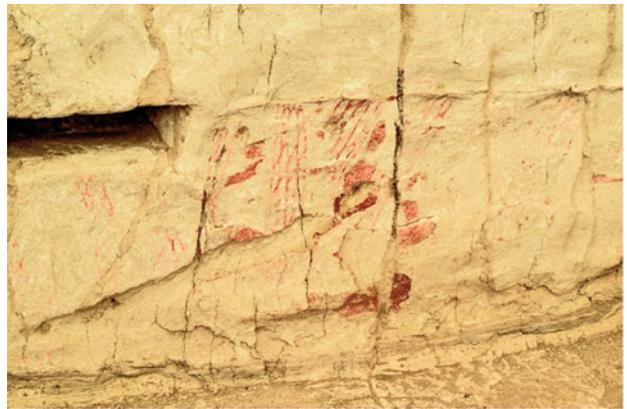
Figure 15.13. East-facing photograph of painting on east wall of B.96 (photograph by Gesualdo Busacca).

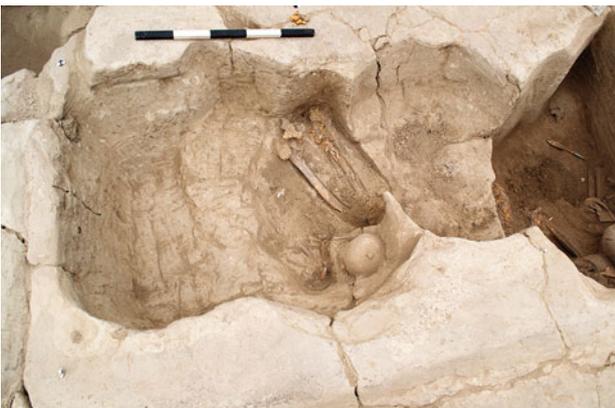
Figure 15.14. East-facing photograph of burial F.7008 and the cut for F.7007 (photograph by Johanna Bergqvist).

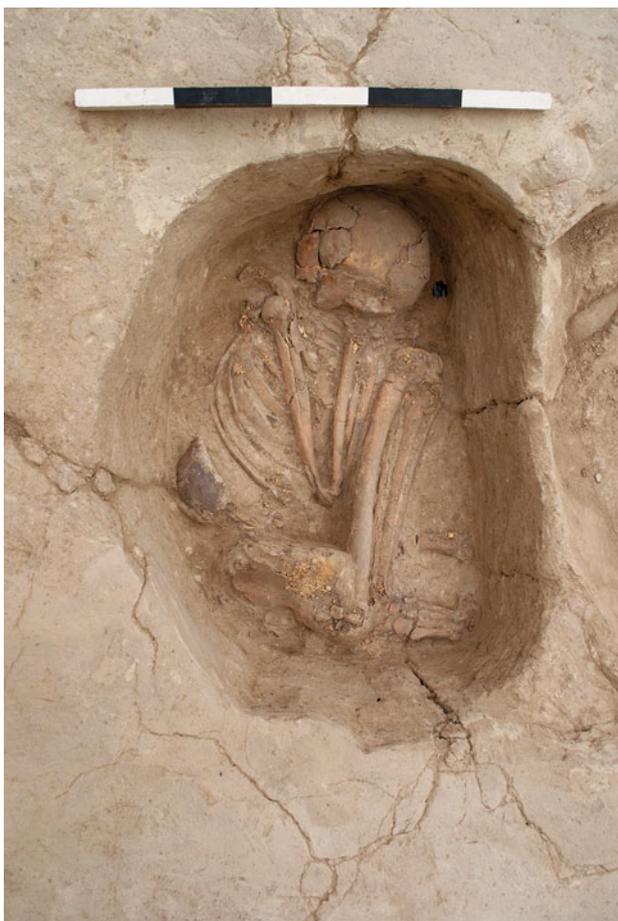
Figure 15.15. West-facing photograph of burial F.7003 (photograph by Alison Mickel).

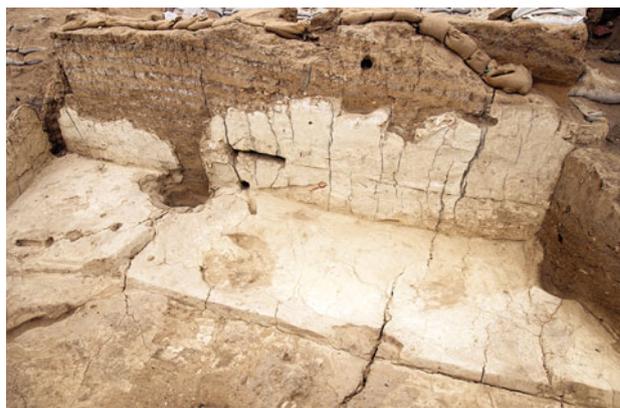
Figure 15.17. Northeast-facing photograph showing white plaster floor surfaces ((19714) and (19713)) on the platform and across the central part of Space 370 (photograph by Jason Quinlan).

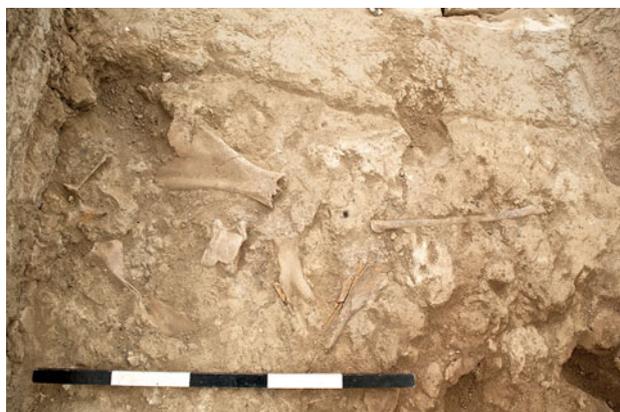
Figure 15.18. West-facing photograph showing animal bone cluster in Space 444 (20883) (photograph by Alison Mickel).

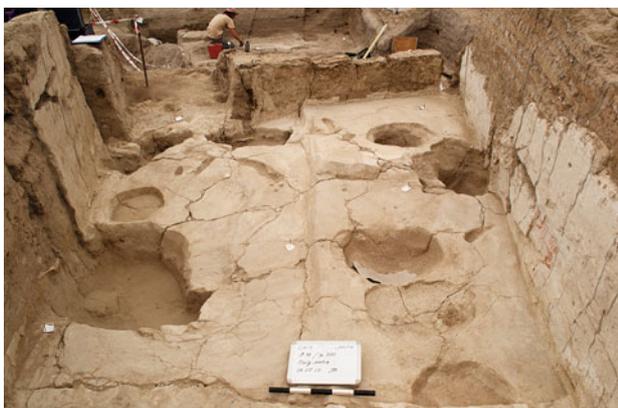
Figure 15.19. North-facing overview of the north end of Space 370, showing post-retrieval pits (F.3500, F3506 and F3510) (photograph by Johanna Bergqvist).

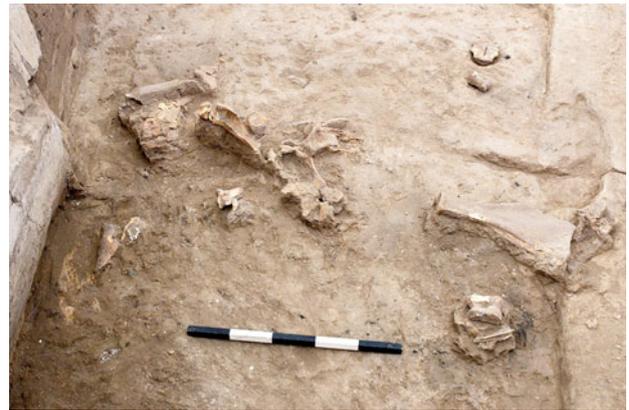
Figure 15.21. North-facing photograph showing primary infill of Space 370 (19227) and a cluster of animal bone, which may be associated with the large abandonment pit F.7000 and possibly linked to other bone concentrations throughout the primary fills of Space 370 (photograph by Johanna Bergqvist).

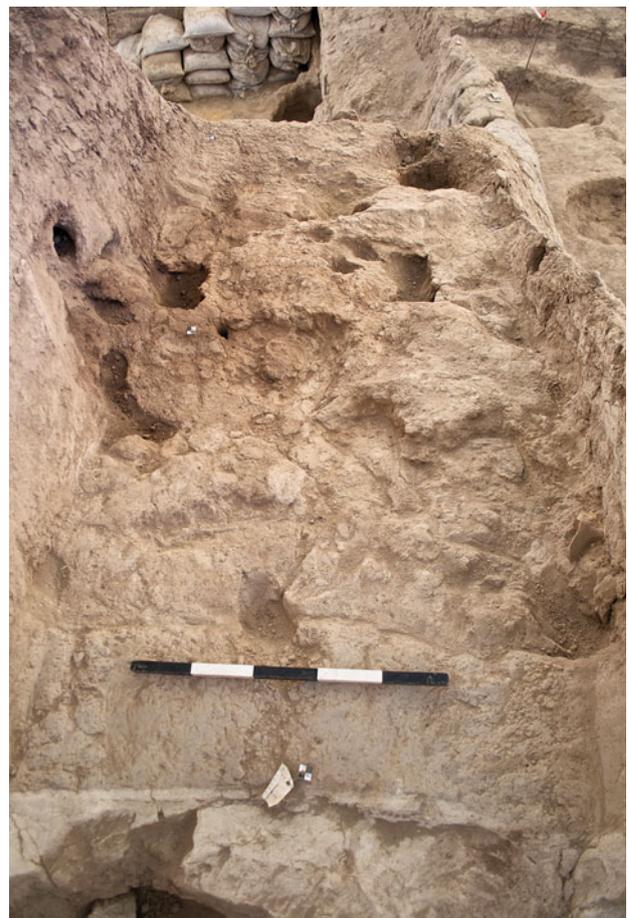
Figure 15.22. North-facing photograph showing the latest burnt infill deposits associated with northern Space 444 (photograph by Allison Mickel).
