Çatalhöyük Excavations: The 2009–2017 Seasons

Supplementary material to Chapter 26. Building 114

Burcu Tung

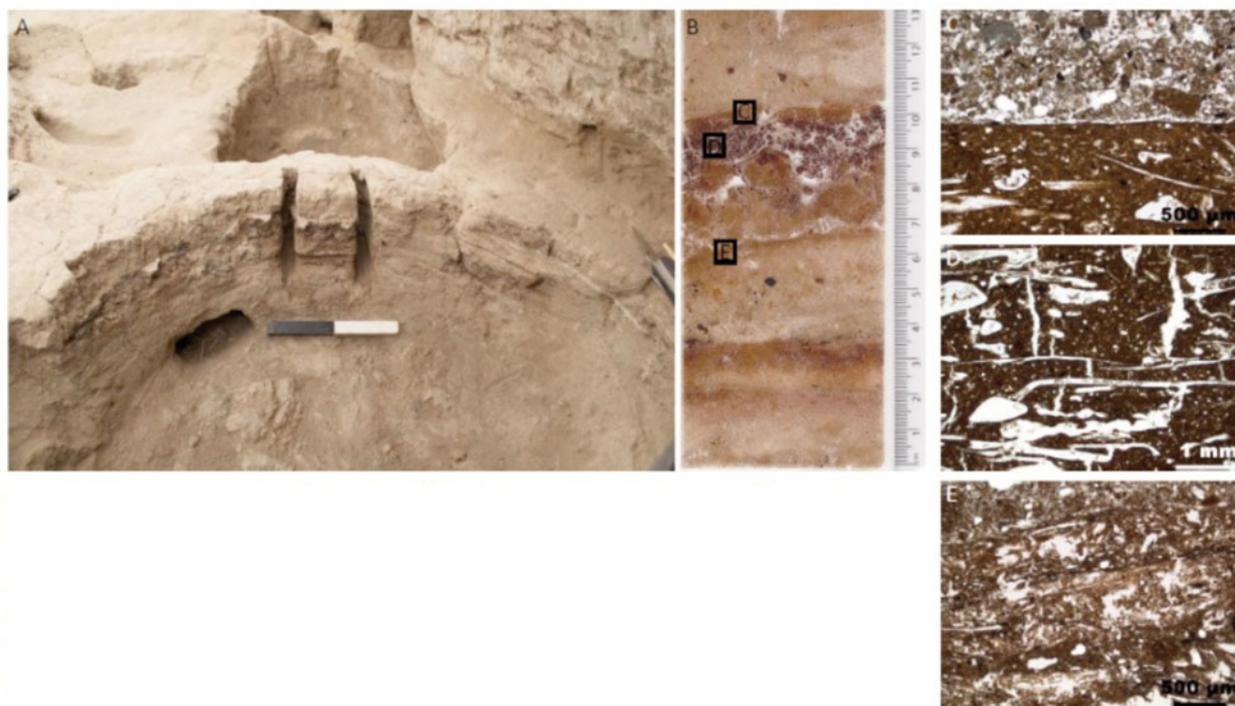
Figure S26.1. (A) Block sample (21572-1), collected from the south-central part of B.114, between burial pits F.7614 and F.7615; (B) scan of micromorphological thin-section (21572-1); (C) photomicrograph of prominent, sharp boundary between coarse floor/packing deposit (top) and baked floor (bottom), PPL; (D) photomicrograph of heavily tempered oven floor deposit displaying a high degree of rubefaction, PPL; (E) photomicrograph of disaggregated herbivore faecal matter used as stabiliser in wash layer applied on top of a baked floor unit, PPL (source: Aroa Garcia Suarez).

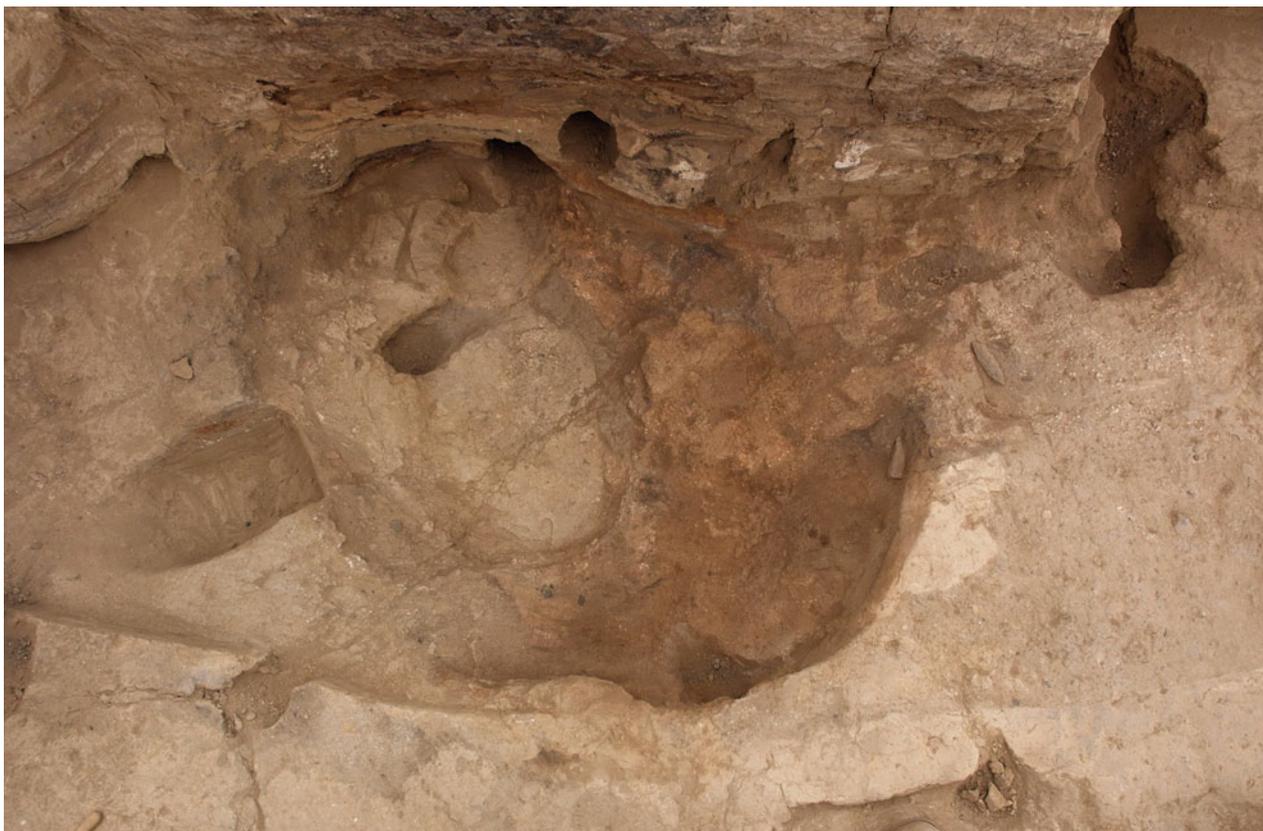
Figure S26.2. Oven F.7607, first floor – both (30014) and (21563) (photograph by Jason Quinlan).

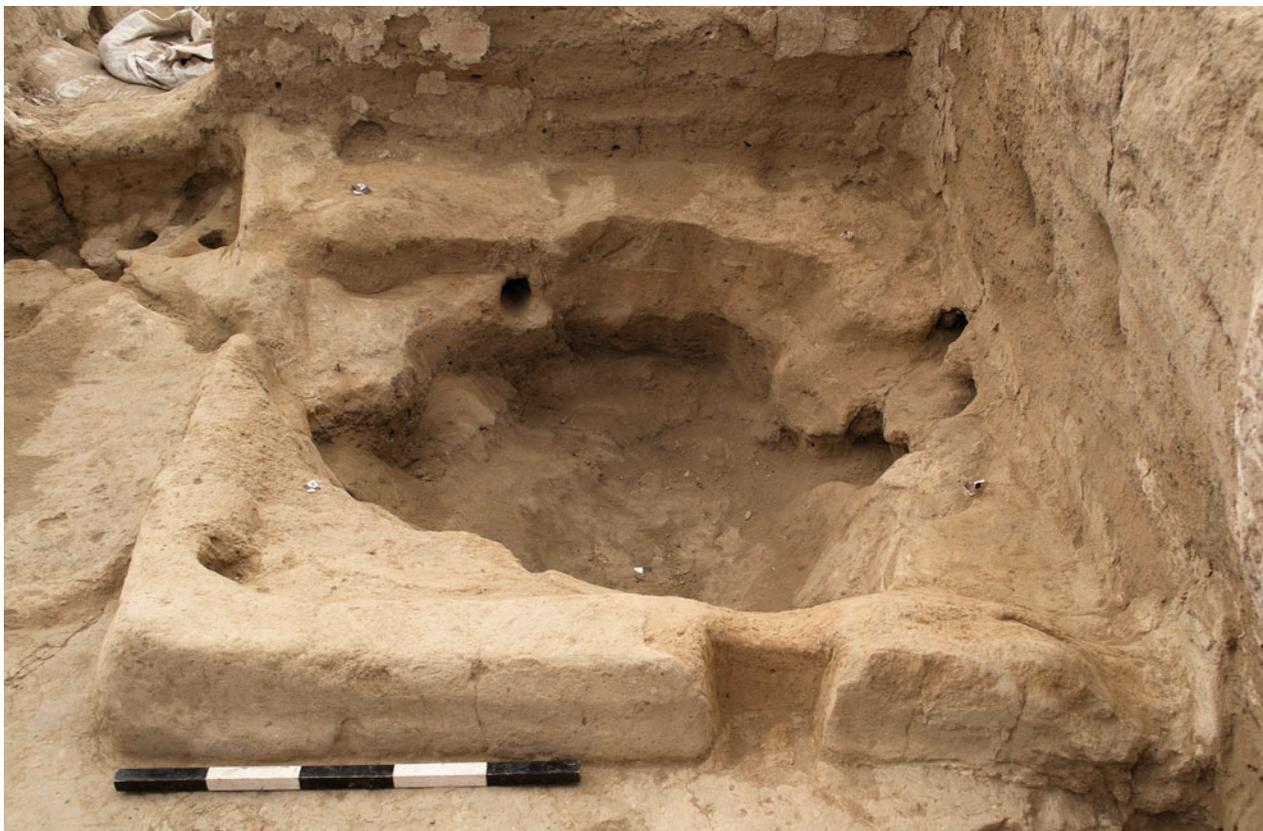
Figure S26.3. Platform F.638 in its early construction (photograph Jason Quinlan).

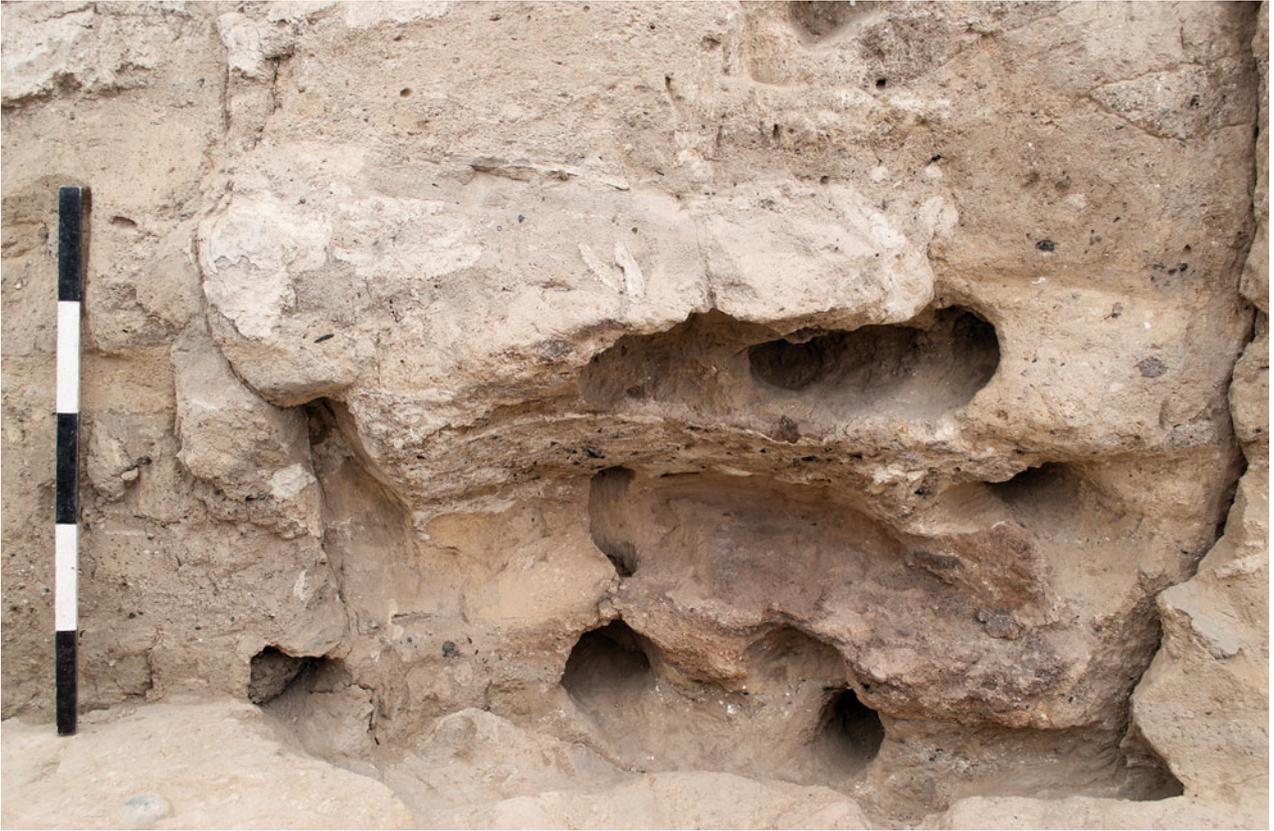
Figure S26.4. Oven F.7607 turned into a niche with plaster (30015) (photograph by Jason Quinlan).

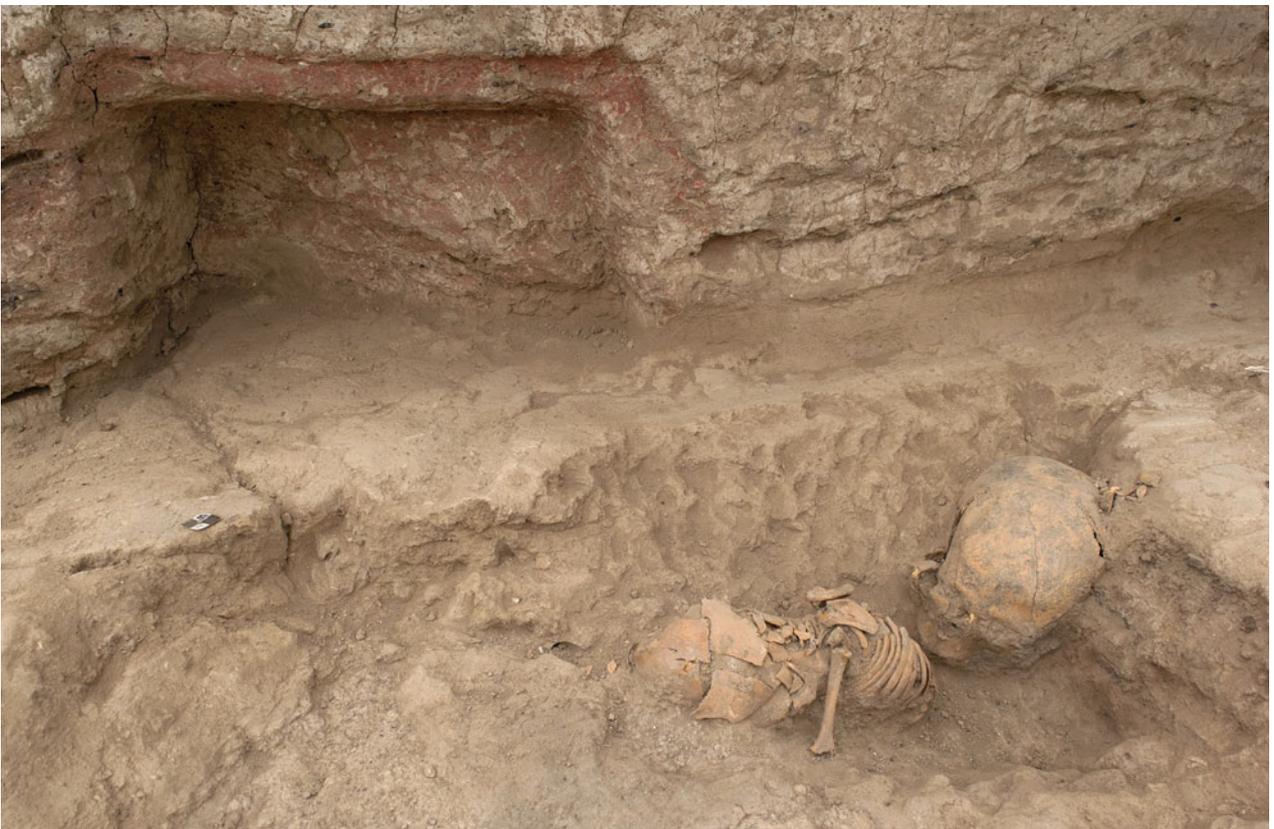
Figure S26.5. South-facing view of burial F.7615, infant (30006). The infant has been placed on the chest of the adult (photograph by Scott Haddow).

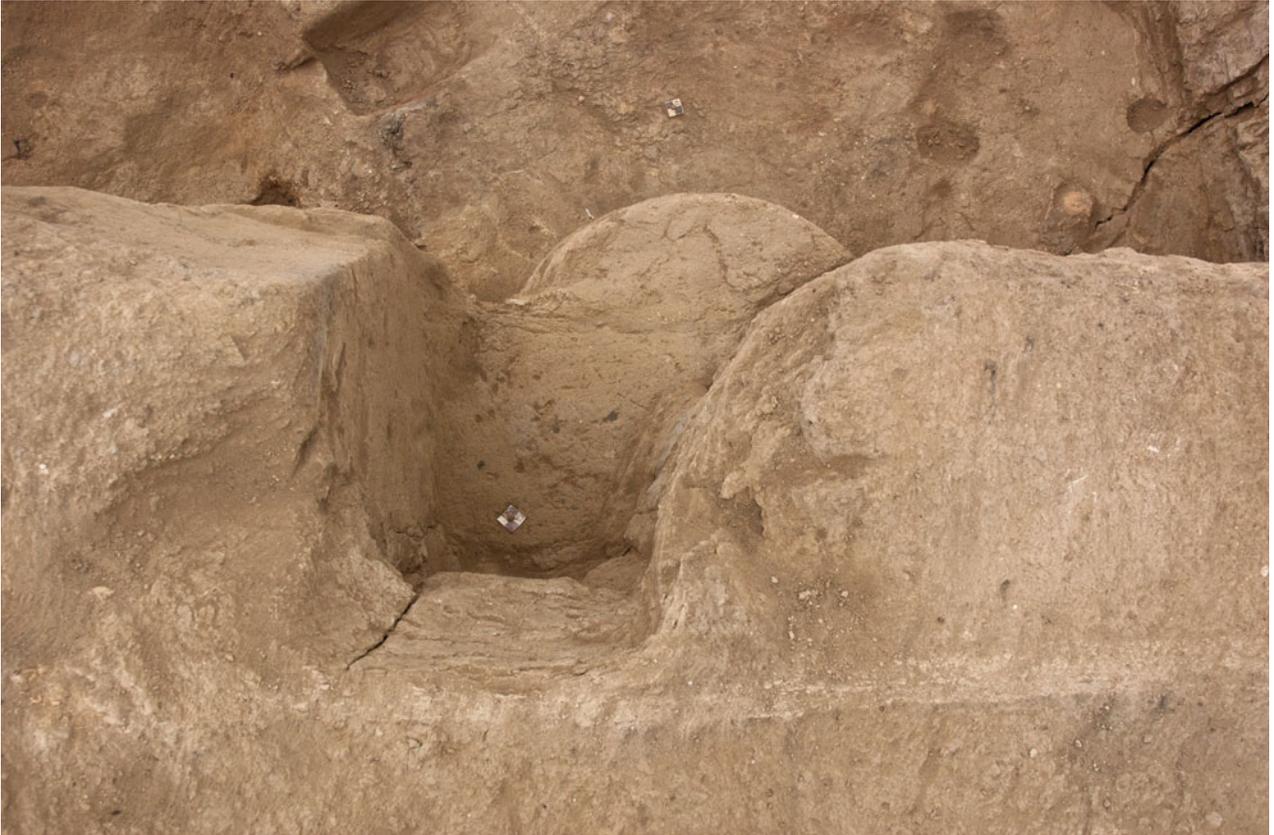
Figure S26.6. Plan view of the cut made for the placement of a ladder upon F.7657. Notice that the step seems to be integrated within the wall, not just abutting it, which made it structurally extremely strong (photograph by Aroa Garcia-Suarez).

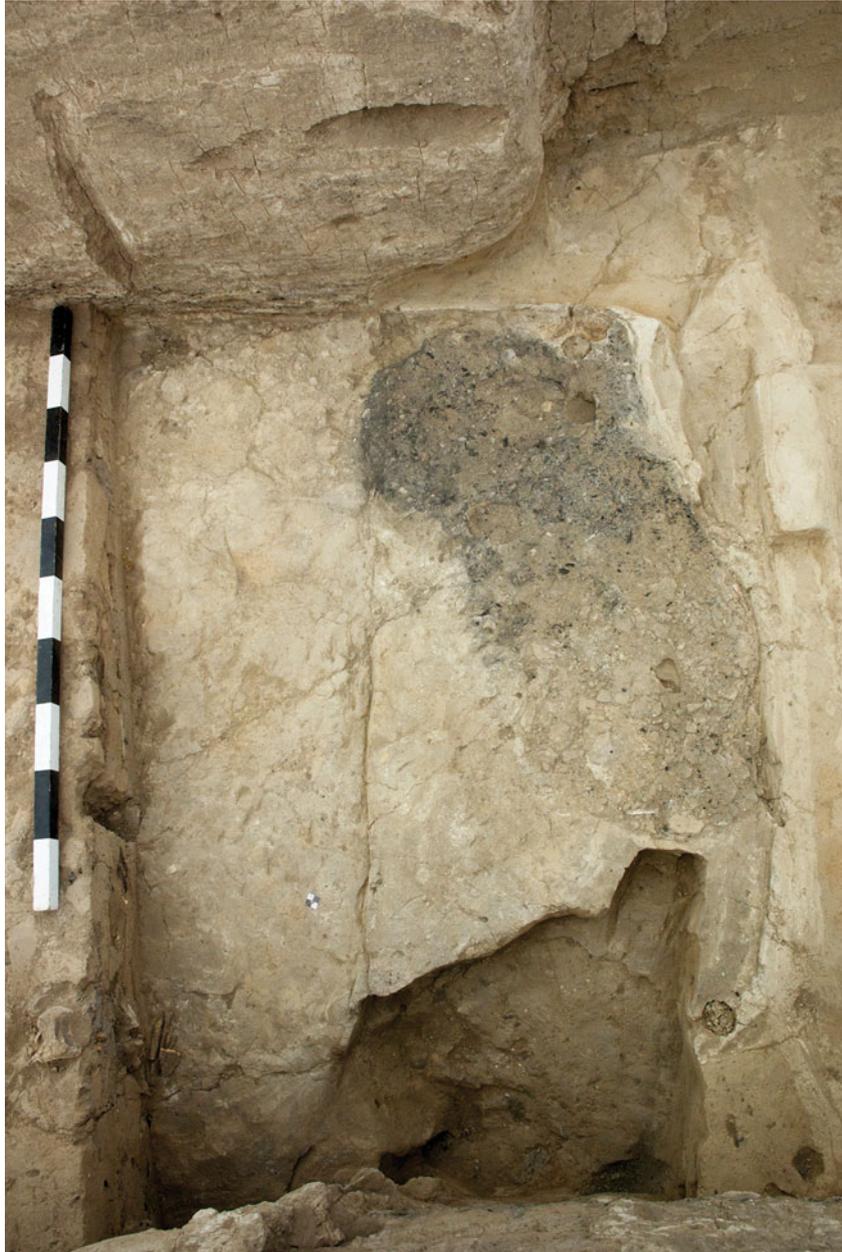
Figure S26.7. North-facing view of context (20961), rich in organic remains within shallow pit F.7129 (photograph by Aroa Garcia-Suarez).

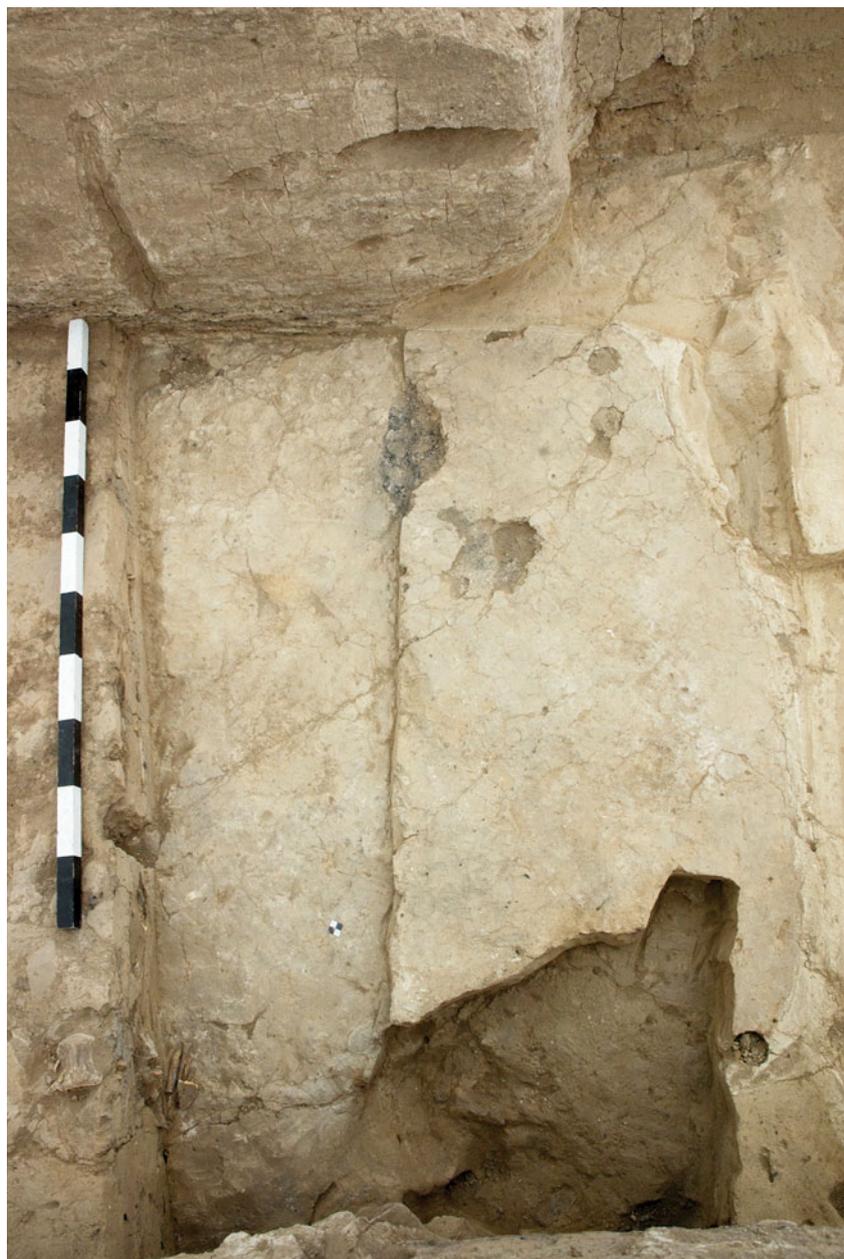
Figure S26.8. North-facing view of floor (20952) sealing shallow pit F.7129 (photograph by Aroa Garcia-Suarez).

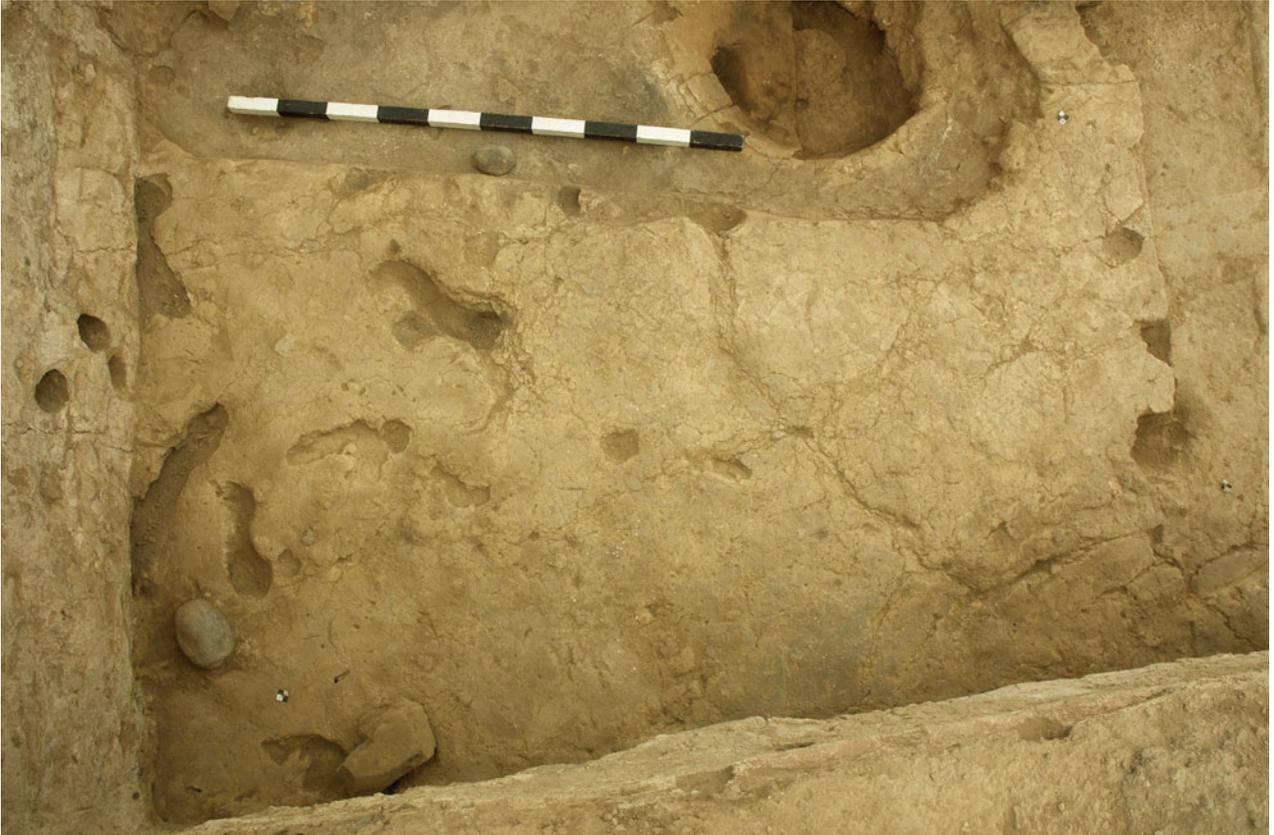
Figure S26.9. Floors (21344) in the southwestern activity area (photograph by Aroa Garcia-Suarez).

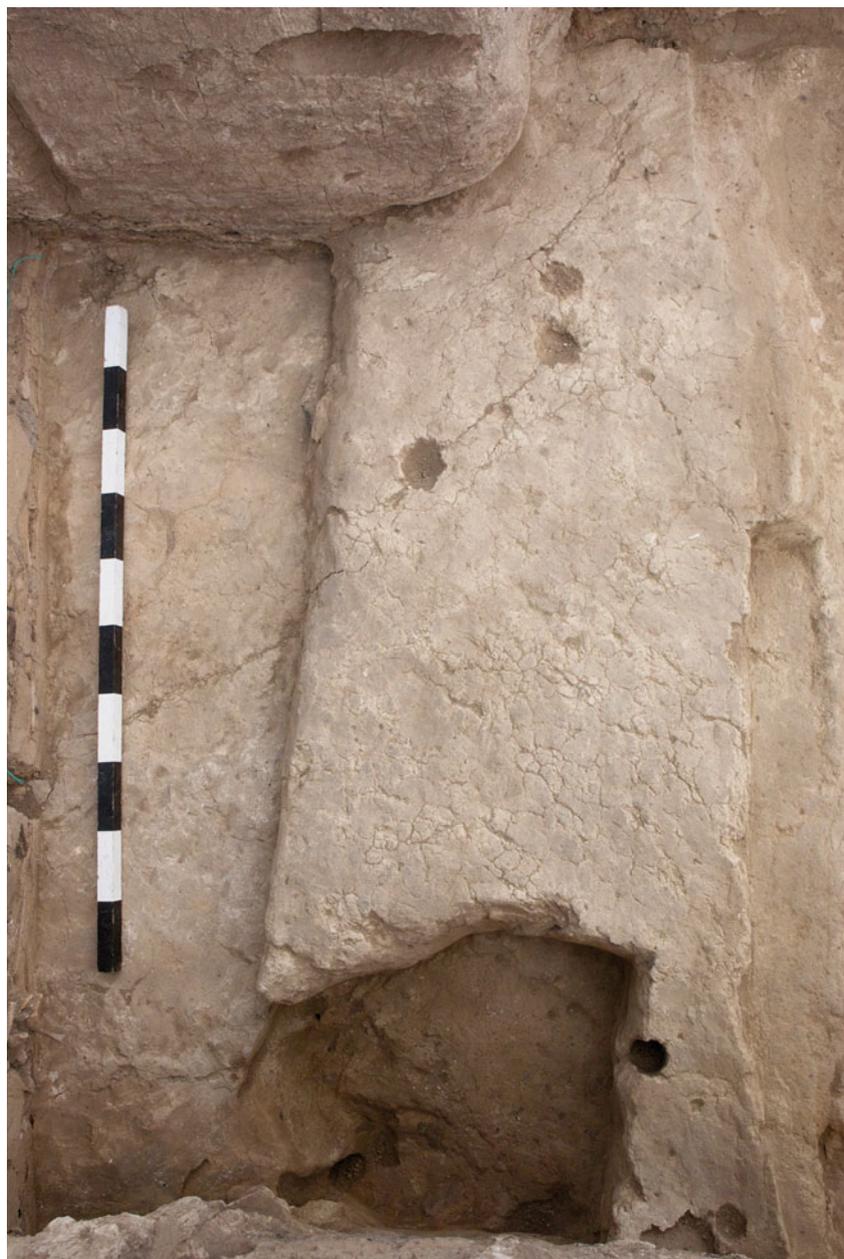
Figure S26.10. North-facing view of platform F.7114, plaster surface (20628) (photograph by Aroa Garcia-Suarez).

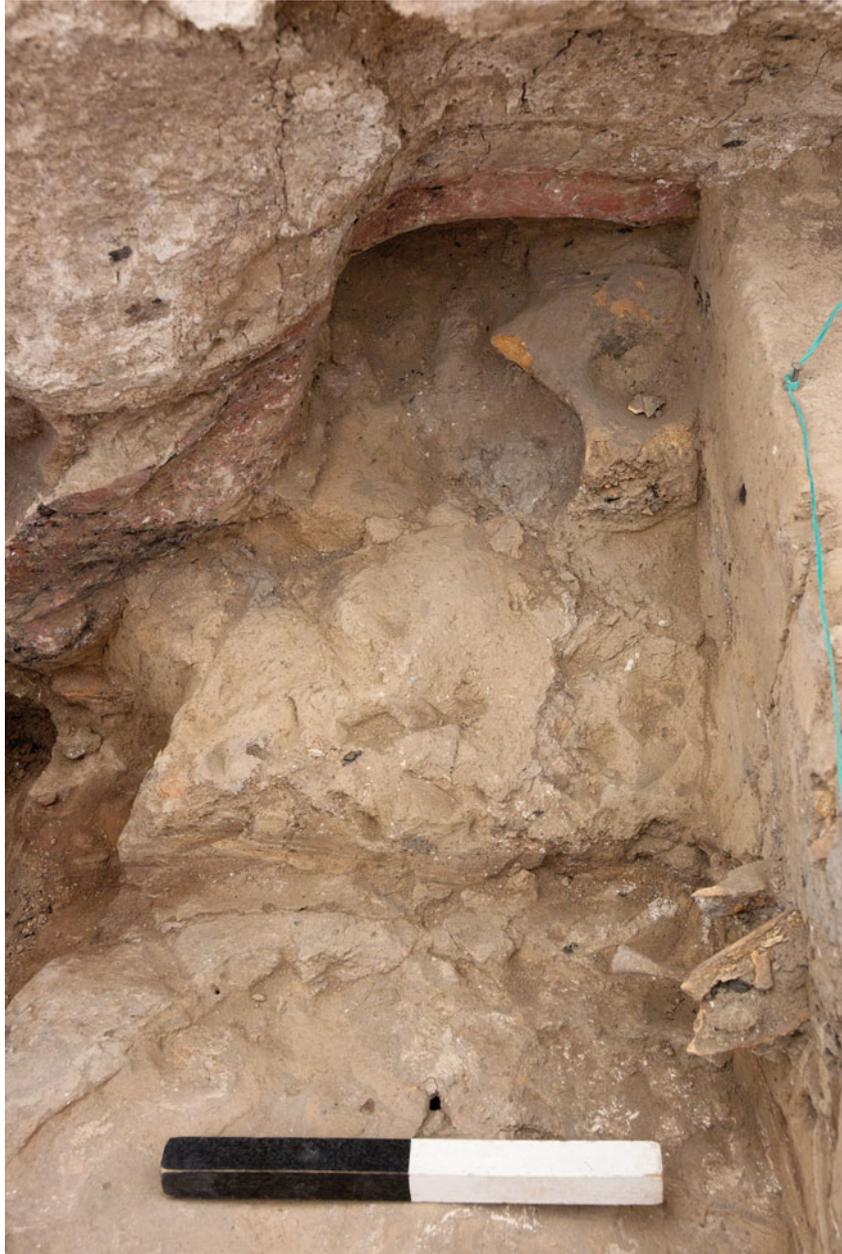
Figure S26.11. Aurochs atlas found in niche F.8143 (photograph by Jason Quinlan).

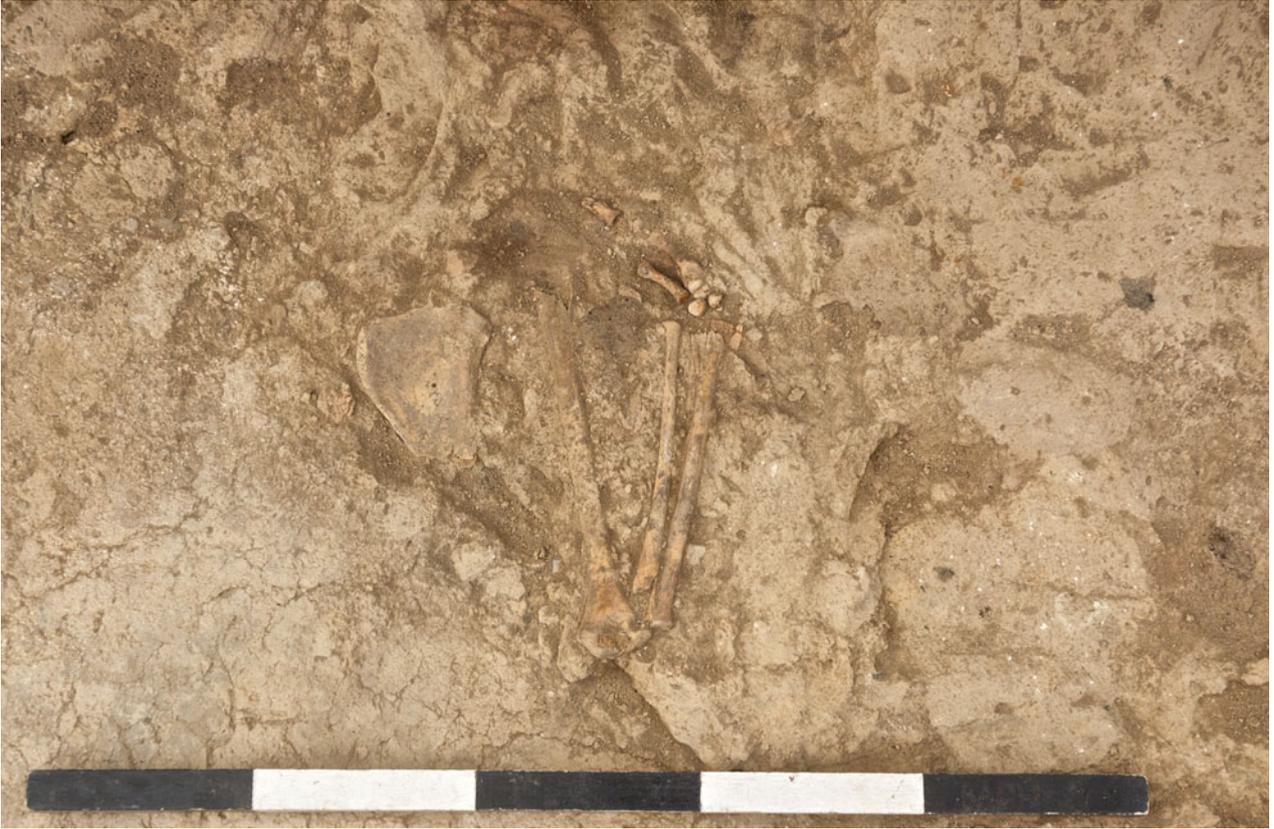
Figure S26.12. Abandonment deposits in B.114. 21113.x24, articulated human arm, including hand and scapula (photograph by Jason Quinlan).

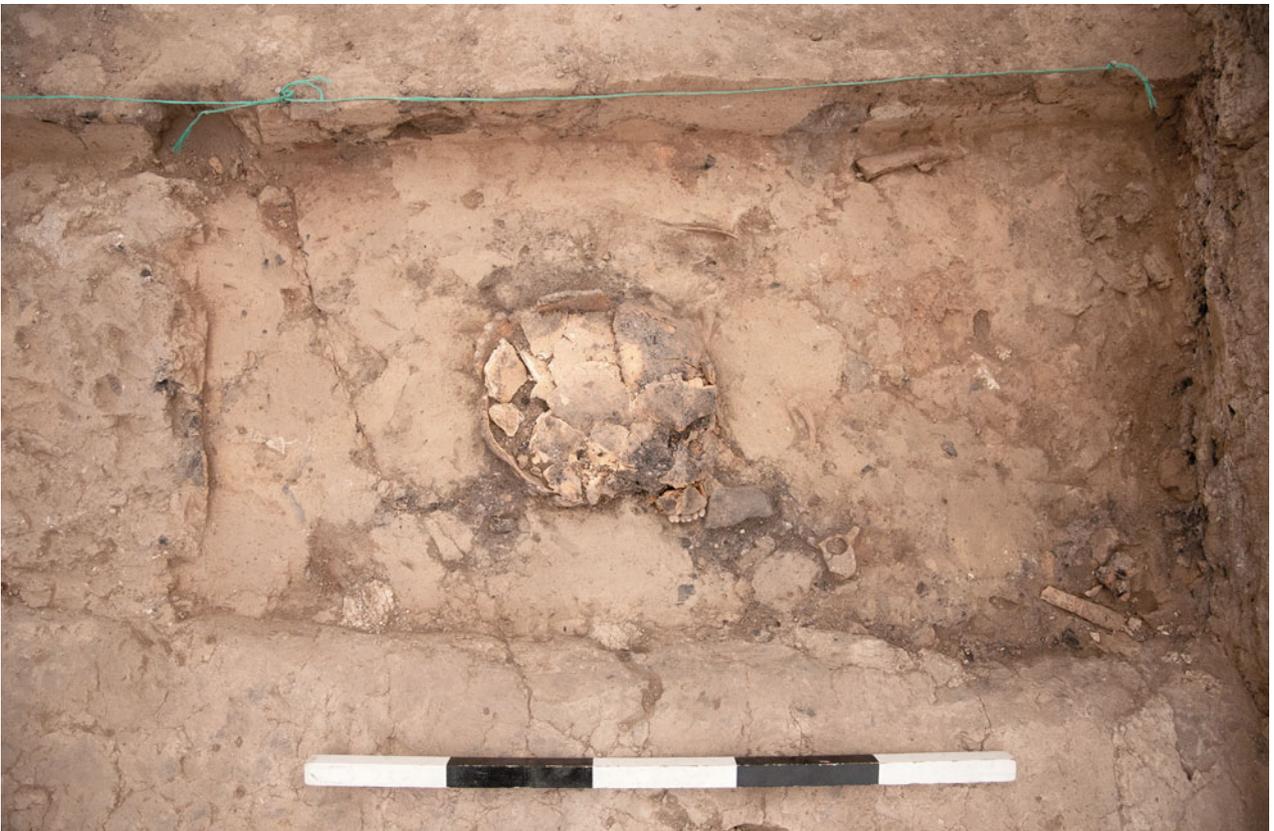
Figure S26.13. Cranium (20682) found within infill (20627) (photograph by Scott Hadow).
