# *Çatalhöyük Excavations: The 2009–2017 Seasons*

## Supplementary material to Chapter 24. Building 108

Burcu Tung

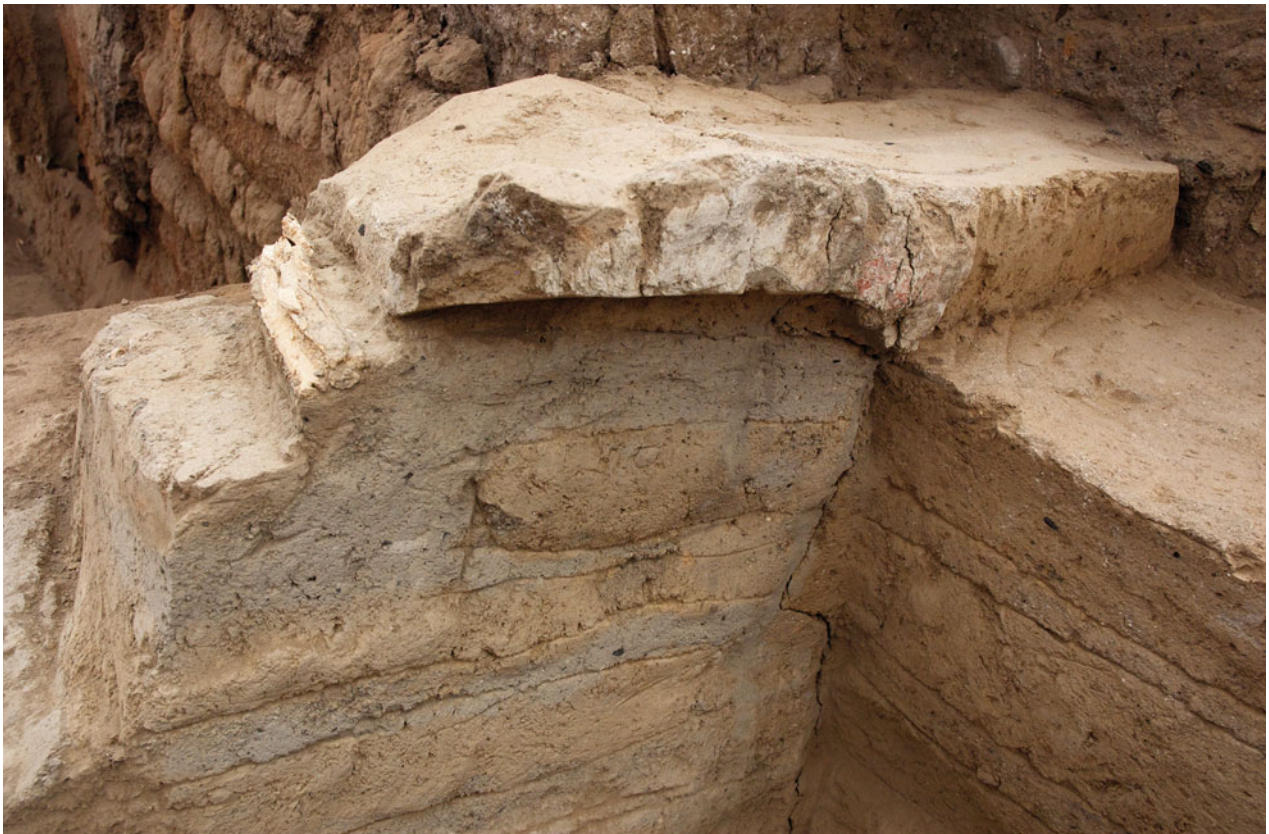
*Figure S24.1. Foundation courses of northern wall F.3636 meet the eastern wall F.3627 in a stepped manner. The use of re-used brick in the construction is evident from the plaster remaining on a single brick, even with traces of red paint (photograph by Arek Klimowicz)*

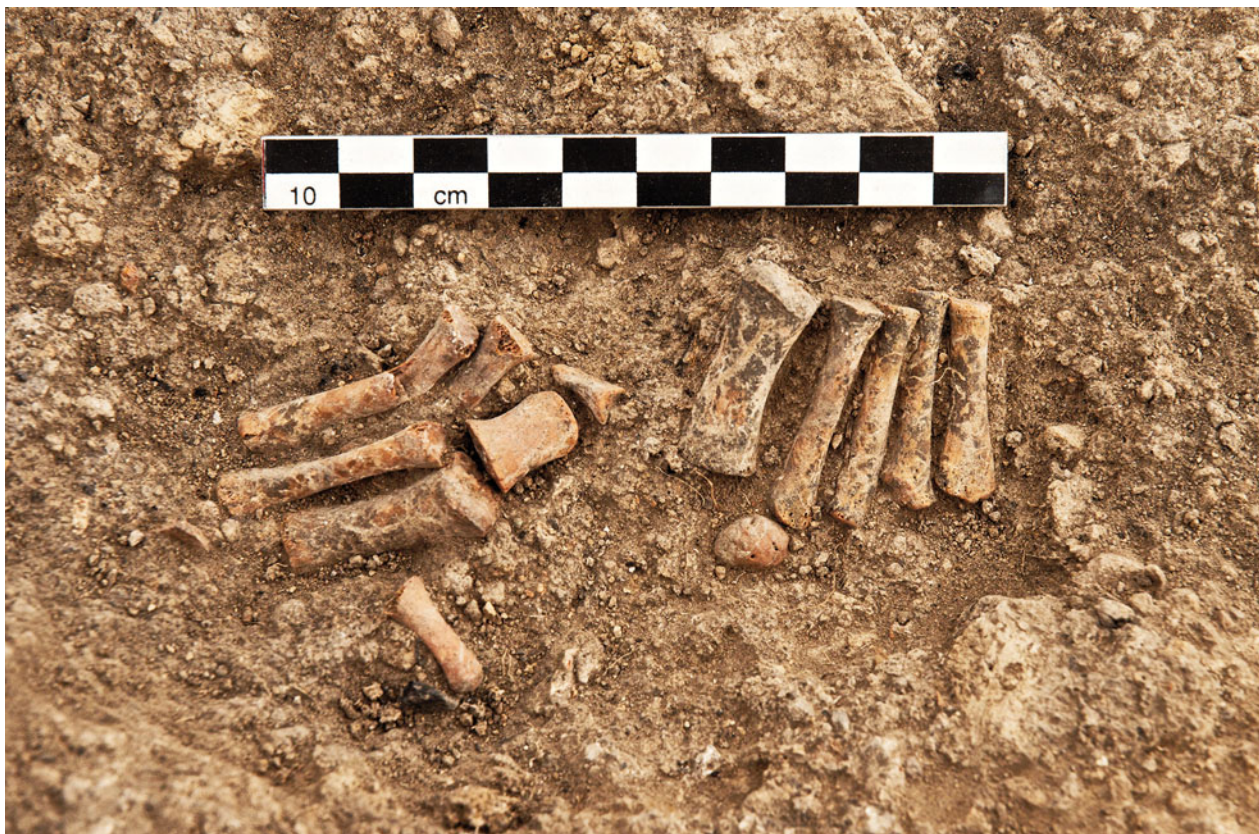
*Figure S24.2. North-facing detail of the articulated feet of skeleton (19437), burial F.3622 (photograph by Jason Quinlan).*

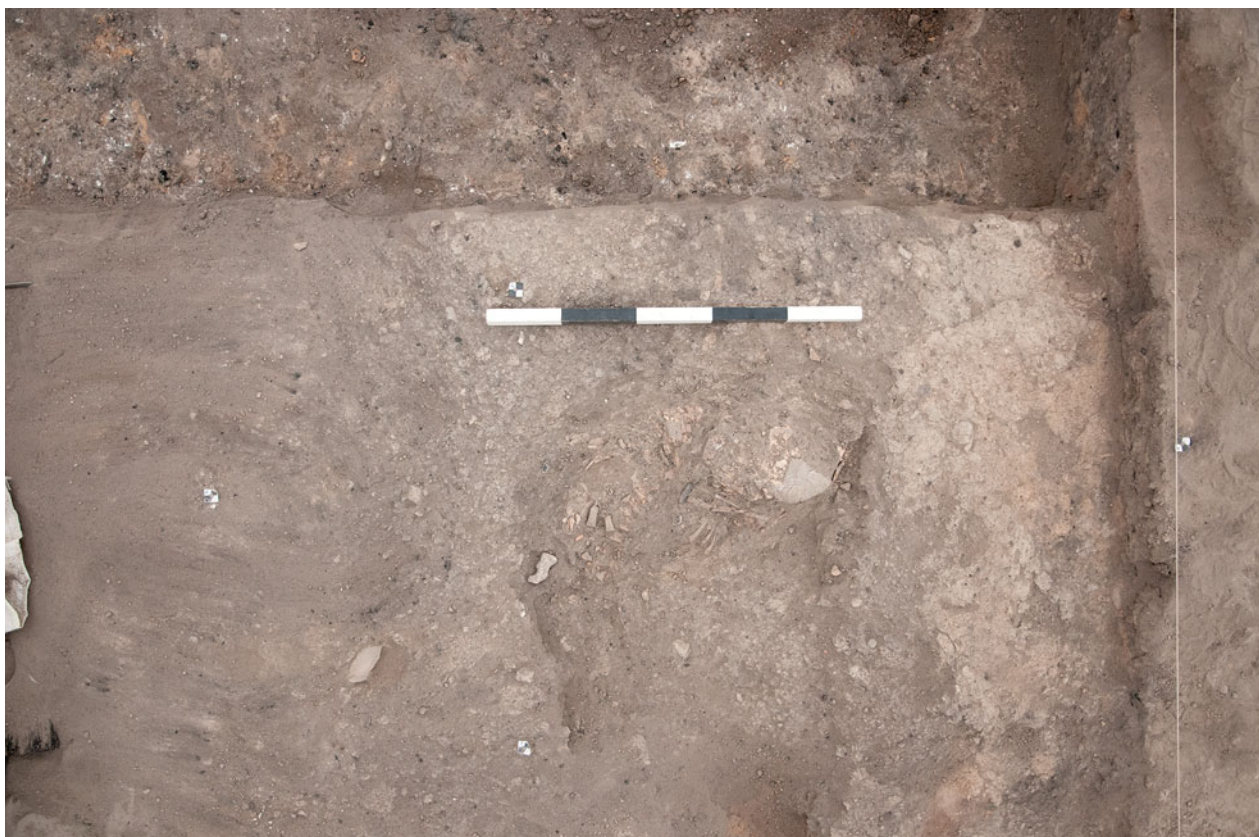
*Figure S24.3. South-facing view of remnants of skeleton (20452) in burial F.3644 (photograph by Scott Haddow).*
