# *Çatalhöyük Excavations: The 2009–2017 Seasons*

## Colour figures for Chapter 22. Building 77

Burcu Tung

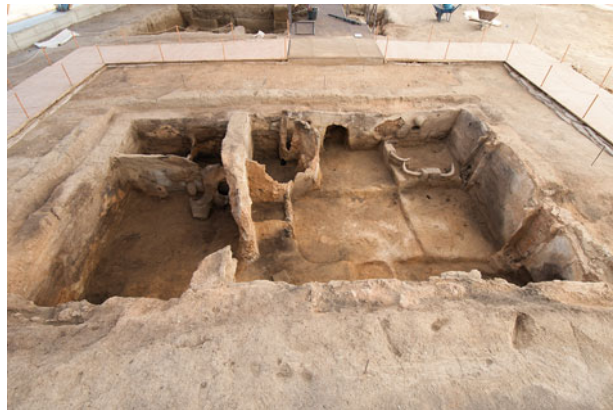
*Figure 22.1. Building 77 in 2008, facing north (photograph by Jason Quinlan).*

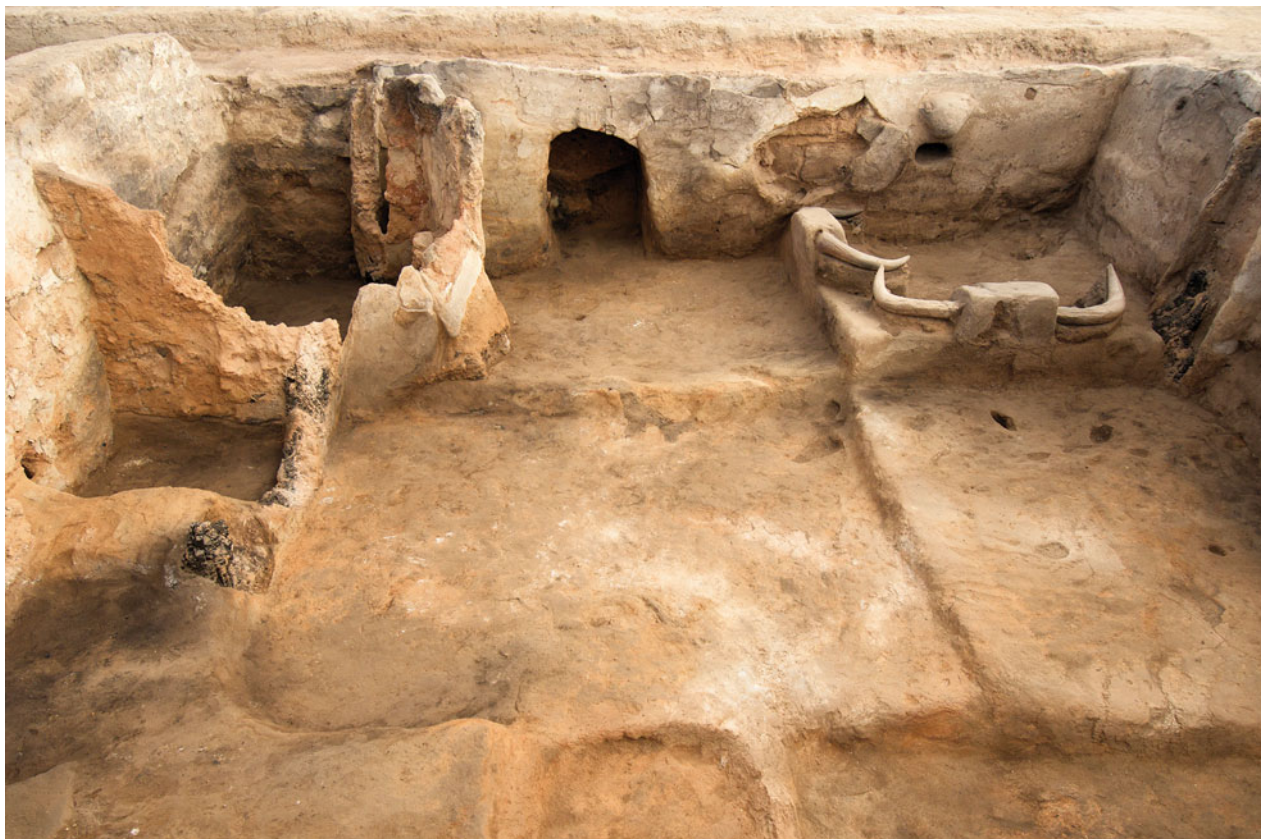
*Figure 22.4. North-facing view of main room (Sp.336) of B.77 in 2008 (photograph by Jason Quinlan).*

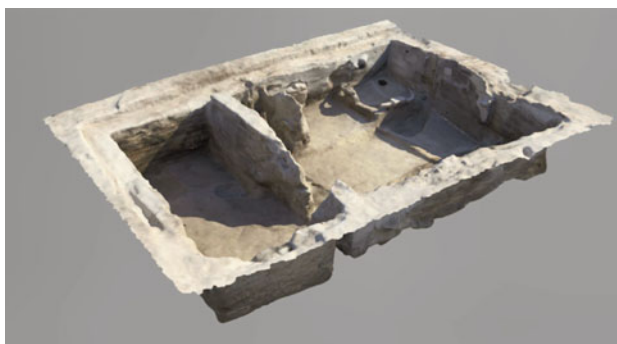
*Figure 22.5. Image-based 3D model of B.77 midway through its excavation (model built by Maurizio Forte and Nicola Lercari).*

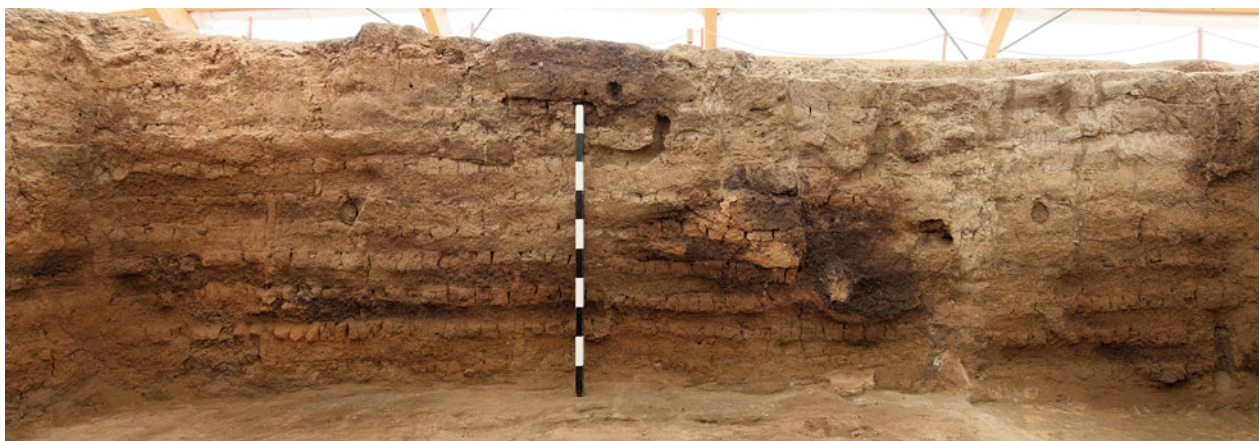
Figure 22.6. Western wall (F.3097) of B.77. Facing west (photograph by Jason Quinlan).

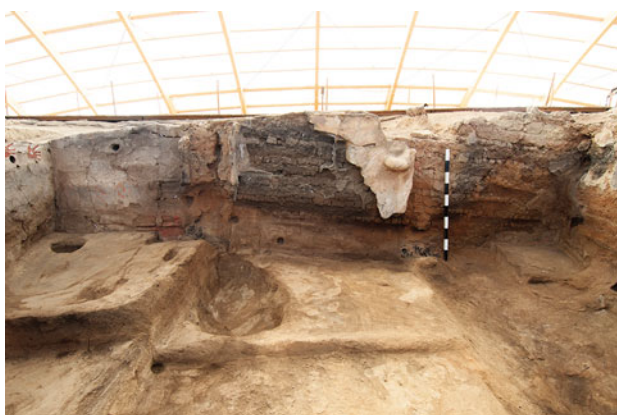
Figure 22.7. Eastern wall F.3095, with engaged posts F.6055 to the north and F.6056 to the south. Facing east (photograph by Jason Quinlan).

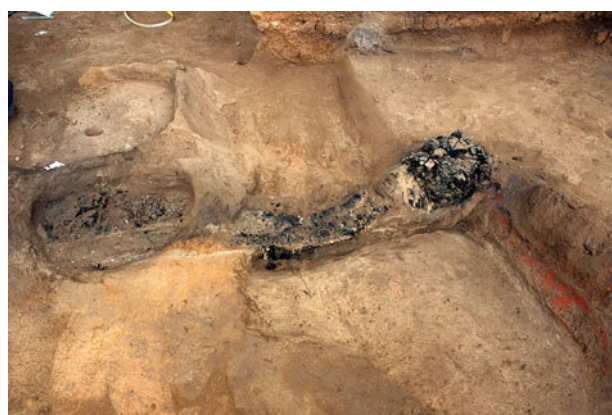
Figure 22.8. Posts F.7593, F.7594 and F.7595 placed parallel to division wall F.3098. West facing (photograph by Daniel Eddisford).

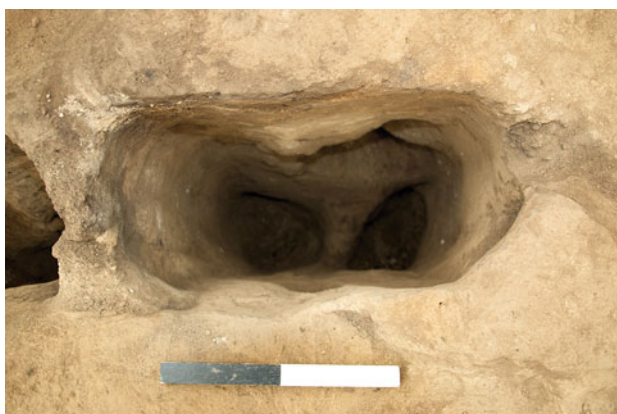
Figure 22.9. The double-based post cut (19599) for post F.7593, facing west (photograph by Susan Hyden).

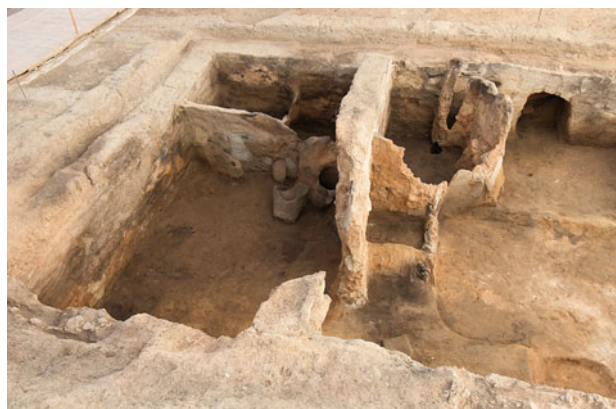
Figure 22.15. North-facing overview of side room Sp.337 (left side of image) in 2008. A clay funnel sits in front of bin complex F.3092 (upper left). This piece may have been the mouthpiece for one of the compartments (photograph by Jason Quinlan).

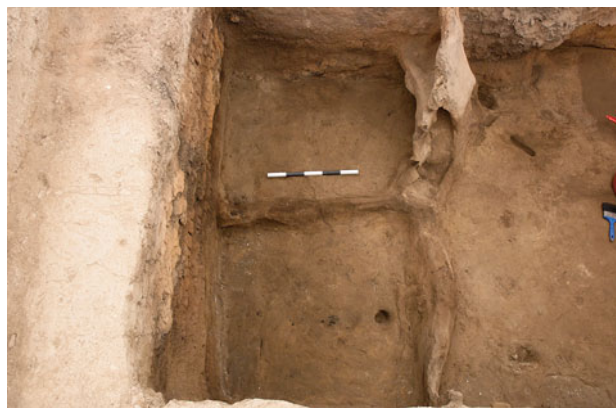
Figure 22.16. East-facing view of double bin F.3092 prior to its excavation in 2010 (photograph by Max Rosefigura).

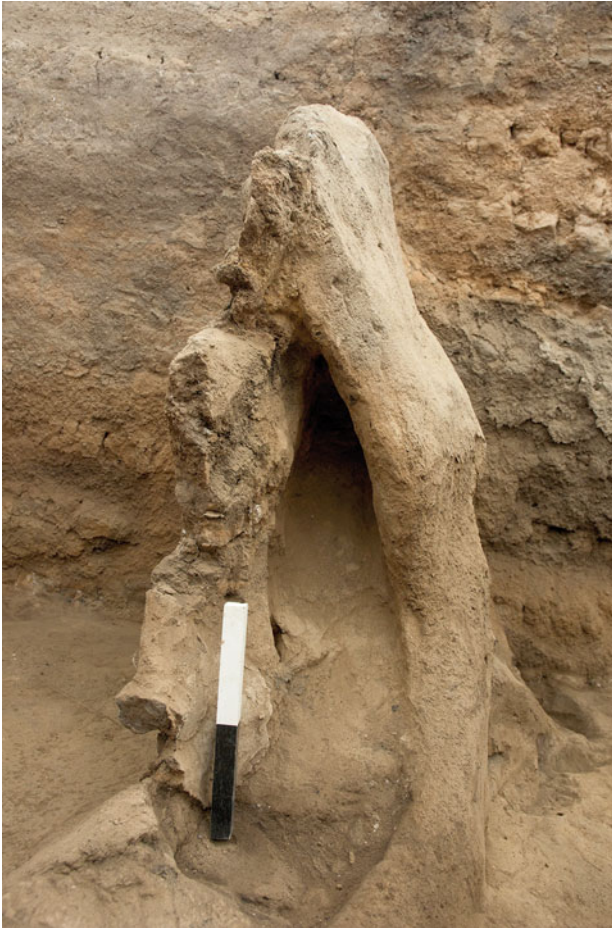
Figure 22.17. Secondary support wall to F.3092, through which the bins may have also been accessed (photograph by Max Rosefigura).

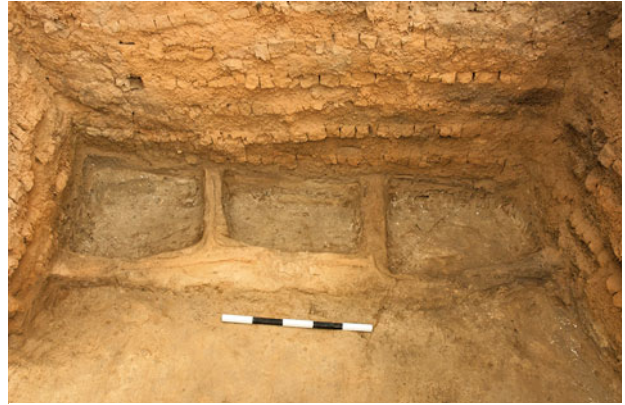
Figure 22.18. The triple basin structure F.3091 prior to its excavation in 2010 (photograph by Max Rosefigura).

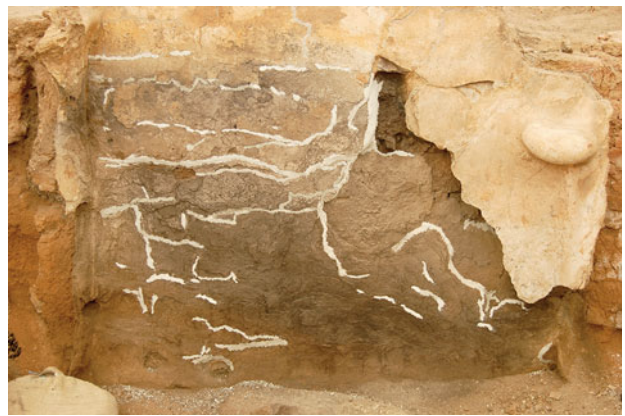
Figure 22.20. Moulding F.6070, conserved and reconstructed in 2009 (photograph by Duygu Çamurcuoğlu).

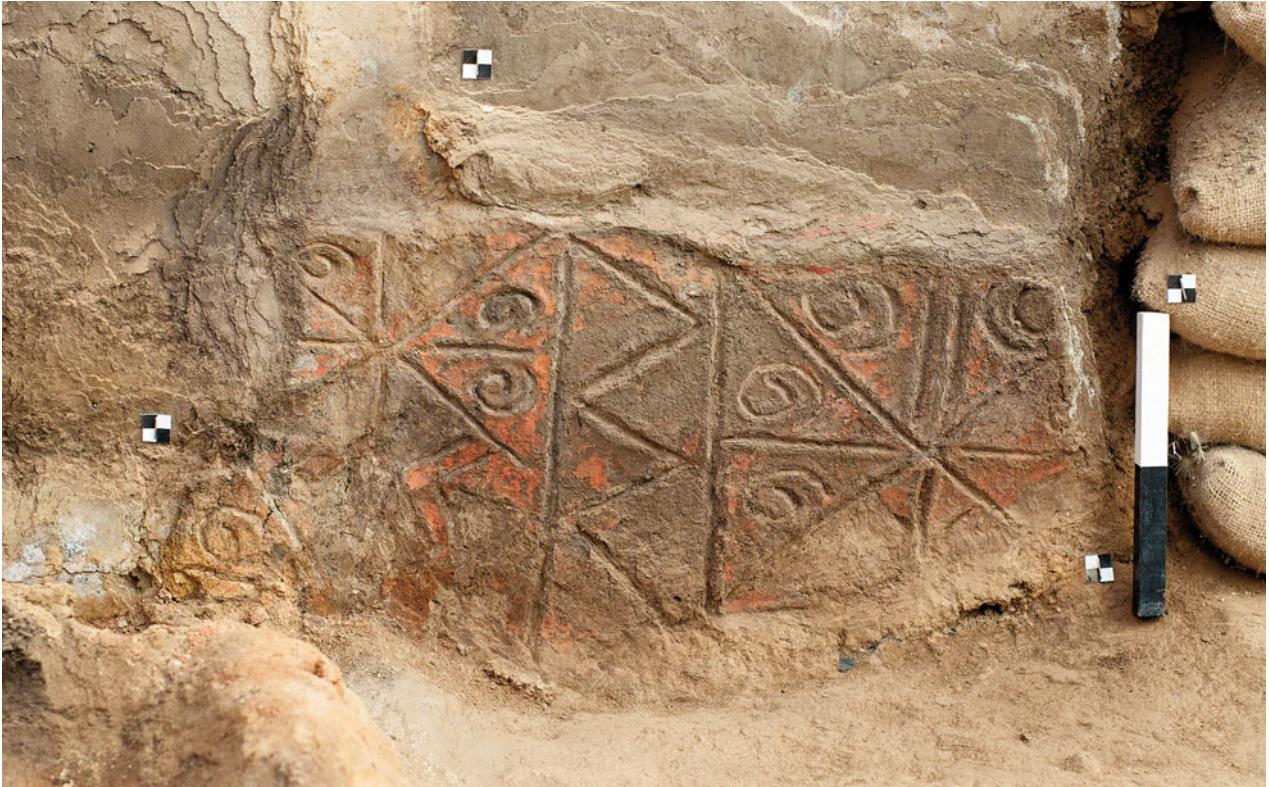
Figure 22.21. Incised panel F.8133 (photograph by Jason Quinlan).

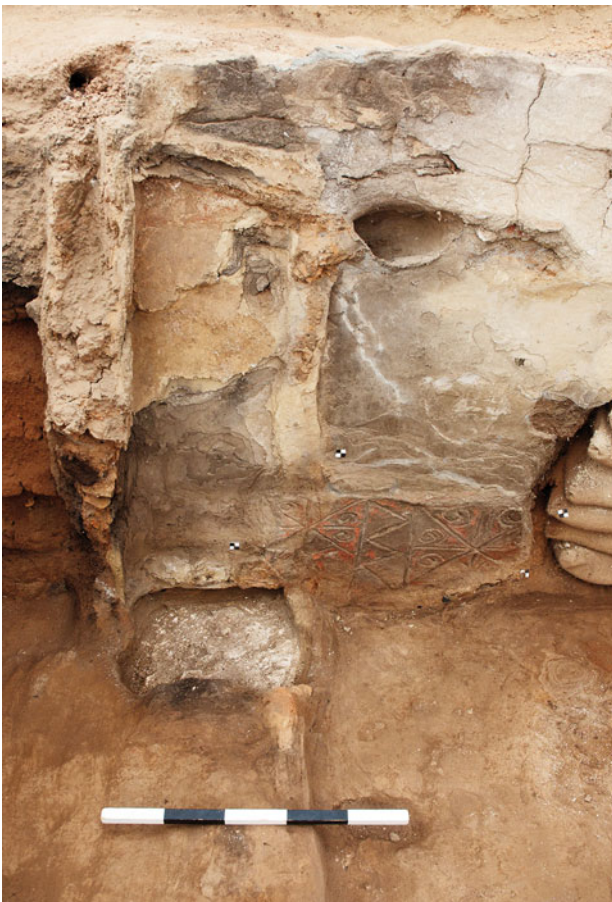
Figure 22.23. Bin F.3613. Notice how the construction of the bin seals the incised panel. The feature was later incorporated into F.6050 (photograph by Jason Quinlan).

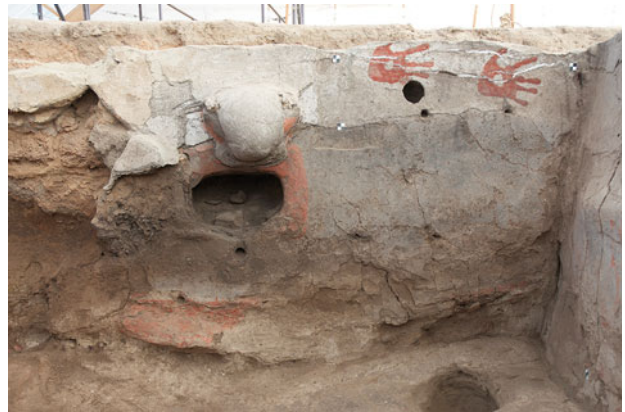
Figure 22.24. The first two prints discovered in 2010. The prints are in fact much earlier than the bucranium, which remains out of phase in this photograph (photograph by Jason Quinlan).

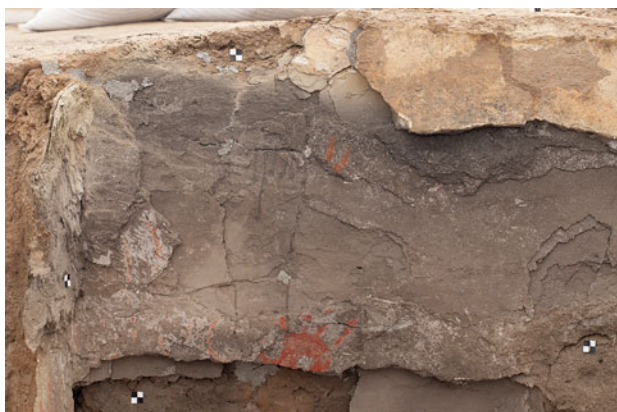
Figure 22.26. Perpendicular handprints on the eastern wall (photograph by Jason Quinlan).

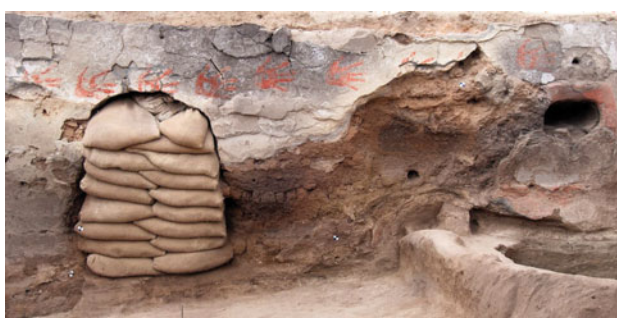
Figure 22.28. The red hand panel as discovered in 2011. It is clear from this image that the prints are contemporary with the red paint that covered niche F.6057 (photograph by Jason Quinlan).

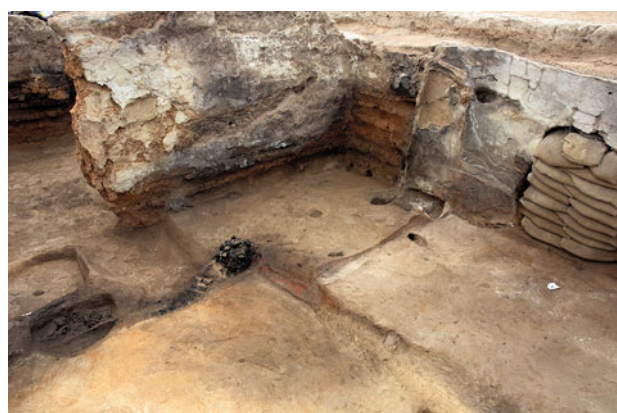
Figure 22.30. Northwest-facing overview of the north-western platform F.3611 at the end of phase B.77.5. Traces of red paint adorn the southern and eastern edges of the platform (photograph by Daniel Eddisford).

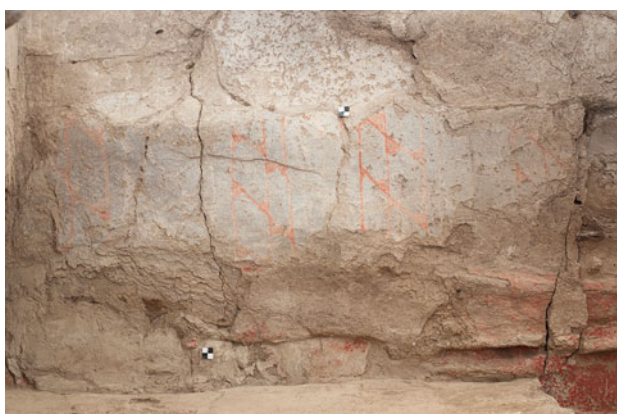
Figure 22.31. Geometric design F.8148, as first uncovered in 2010 by the eastern platform on the lower half of the surviving wall (photograph by Jason Quinlan).

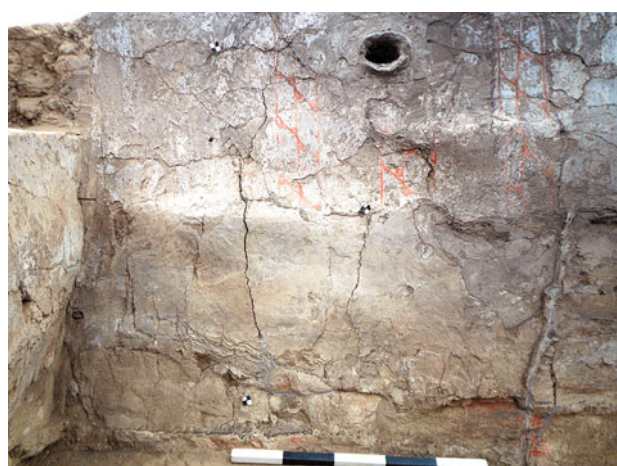
Figure 22.32. Upper part of the geometric design (19469), F.8148 on the eastern wall of B.77 (photograph by Jason Quinlan).

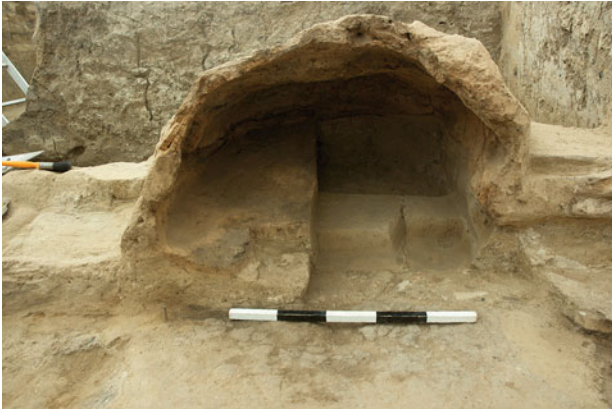
*Figure 22.34. Oven (F.7108) superstructure and earliest floor. Note that wall F.3096 was excavated before the oven was revealed (photograph by Jason Quinlan).*

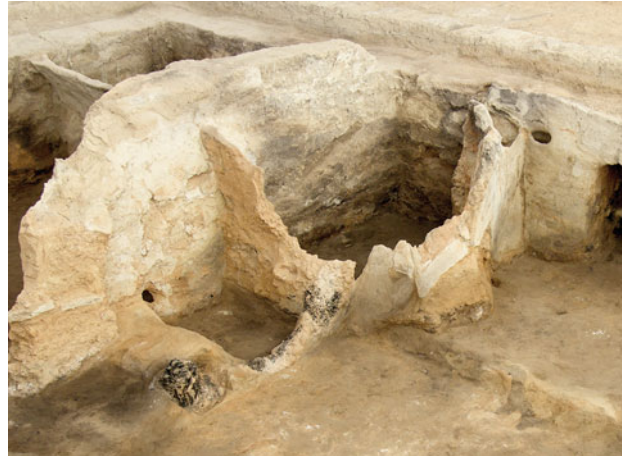
*Figure 22.35. 'Bin' F.6050 at the end of the building's life history (photograph by Jason Quinlan).*

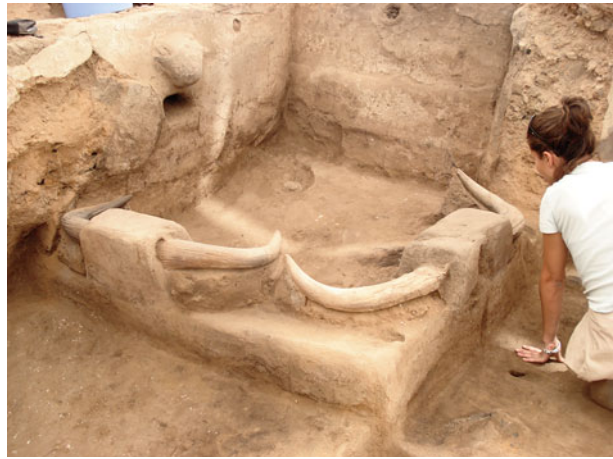
*Figure 22.36. The horned pedestals soon after they were exposed in 2008 (photograph by Michael House).*

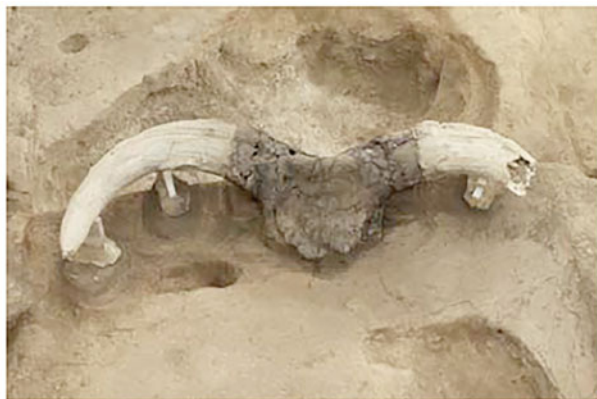
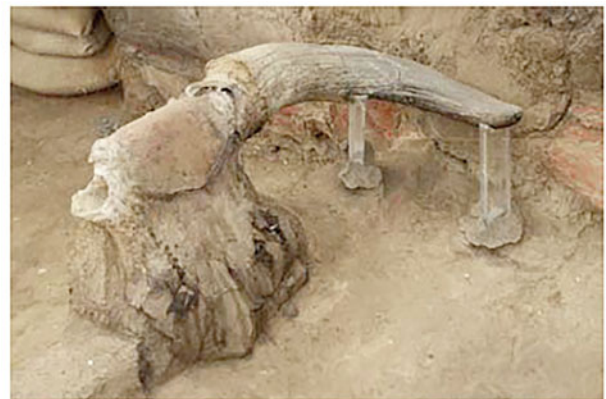
*Figure 22.37. The cores of the horned pedestals (photographs by Jason Quinlan).*

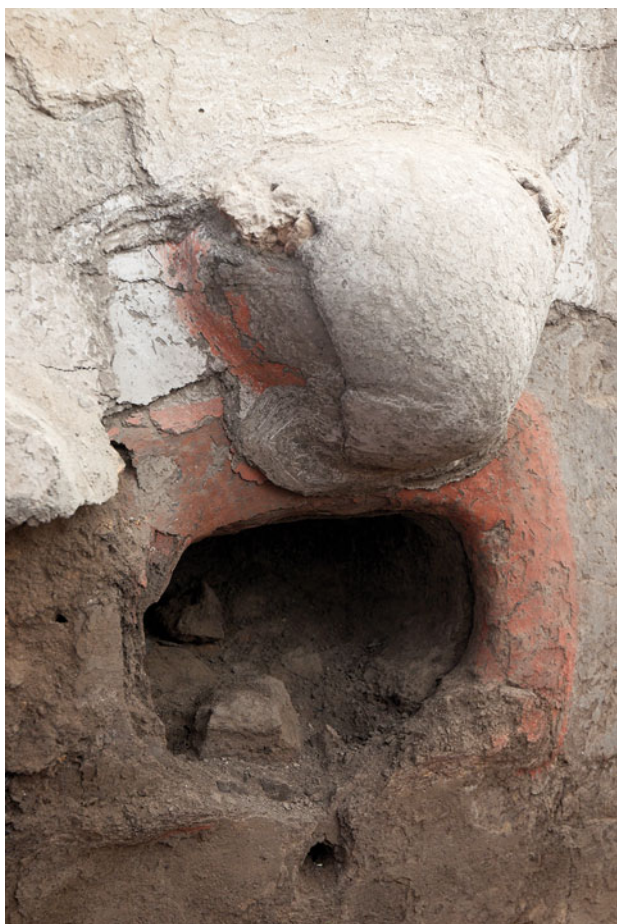
Figure 22.38. Bucranium F.6063 on the northern wall of B.77 (photograph by Jason Quinlan).

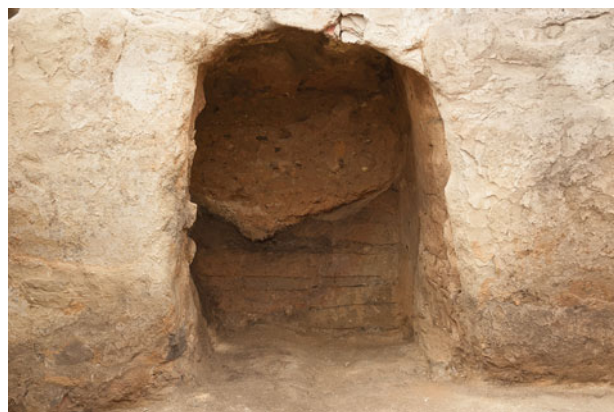
Figure 22.39. Niche F.6063, carved into the northern wall of B.77, in 2008, immediately after its exposure (photograph by Jason Quinlan).

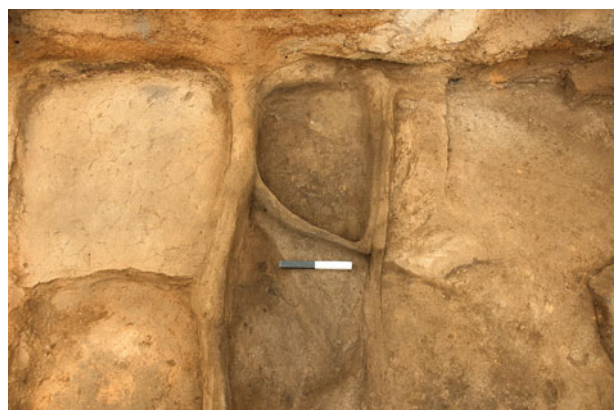
Figure 22.40. Basin F.3605 (photograph by Michael House).

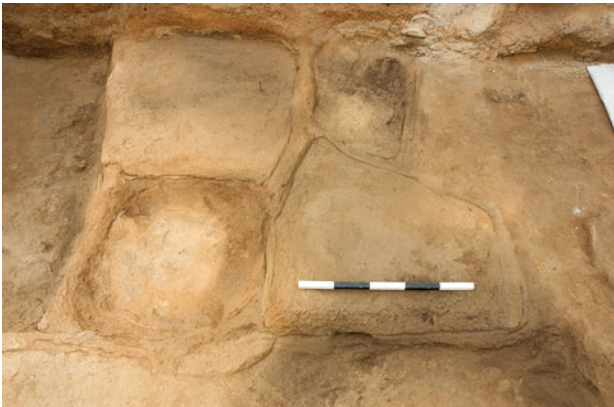
*Figure 22.46. Overview of the southern activity area associated with platform F.6060 (photograph by Jason Quinlan).*

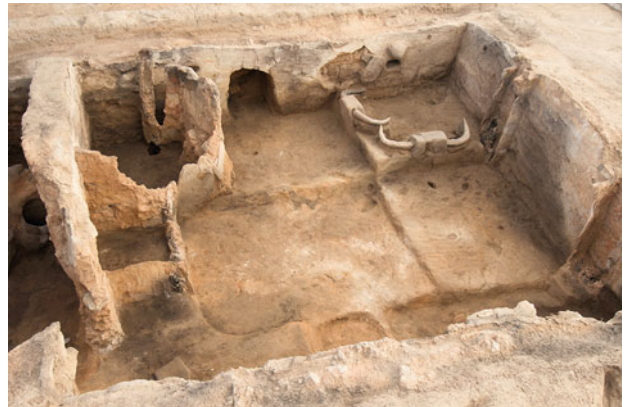
*Figure 22.47. North-facing overview of northern and eastern activity areas in Sp.336 in the final phase of B.77 (photograph by Jason Quinlan).*
