Çatalhöyük Excavations: The 2009–2017 Seasons

Supplementary material to Chapter 25. Building 113, Building 116, Space 532 and other related spaces

Burcu Tung

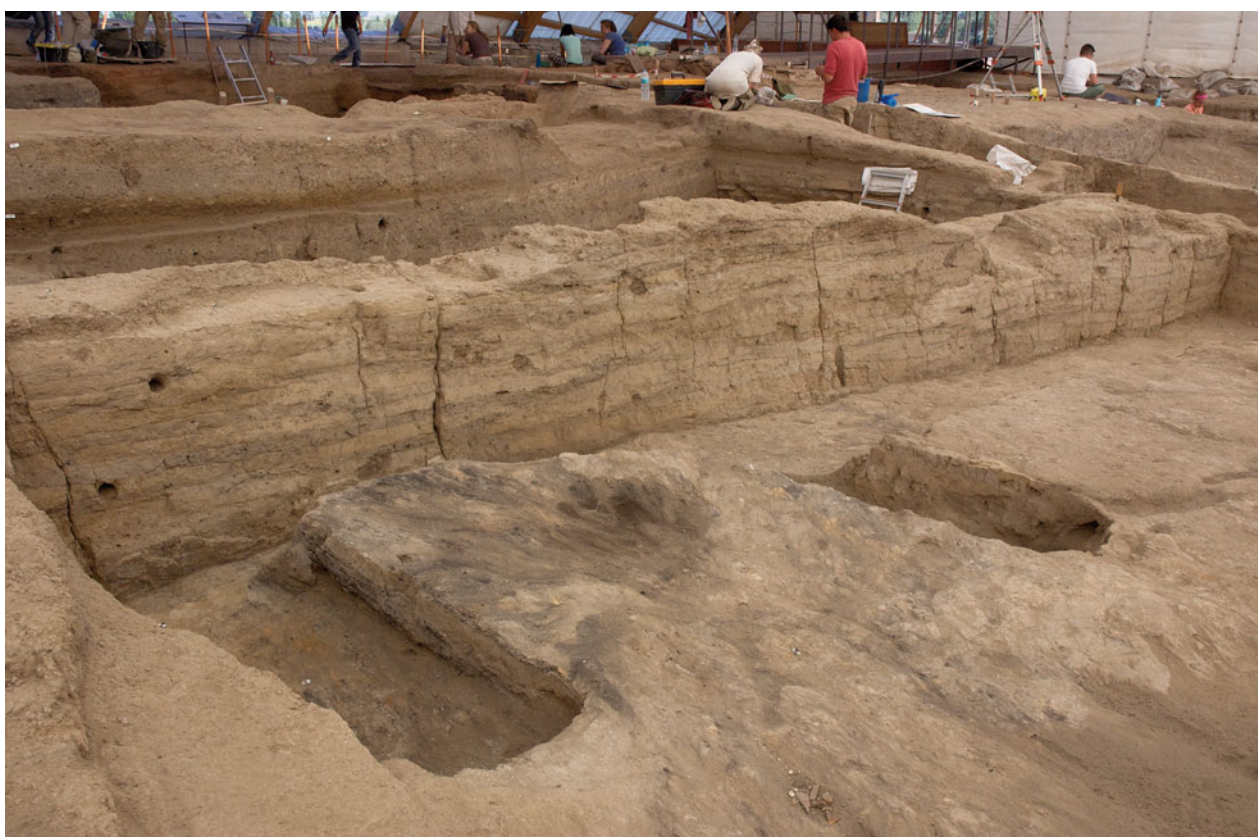
Figure S25.1. Northeast-facing view of the western wall, F.3678, of B.116. Also in the photo are midden deposits that belong to Sp.99 and have been cut by constructional trench F.7338, which has in turn been truncated by two post-Neolithic burials F.3685 and F.3689. Some plaster remains at the southern end of the wall can be seen through the cut of F.3689 (photograph by Sofie Ekstrand).

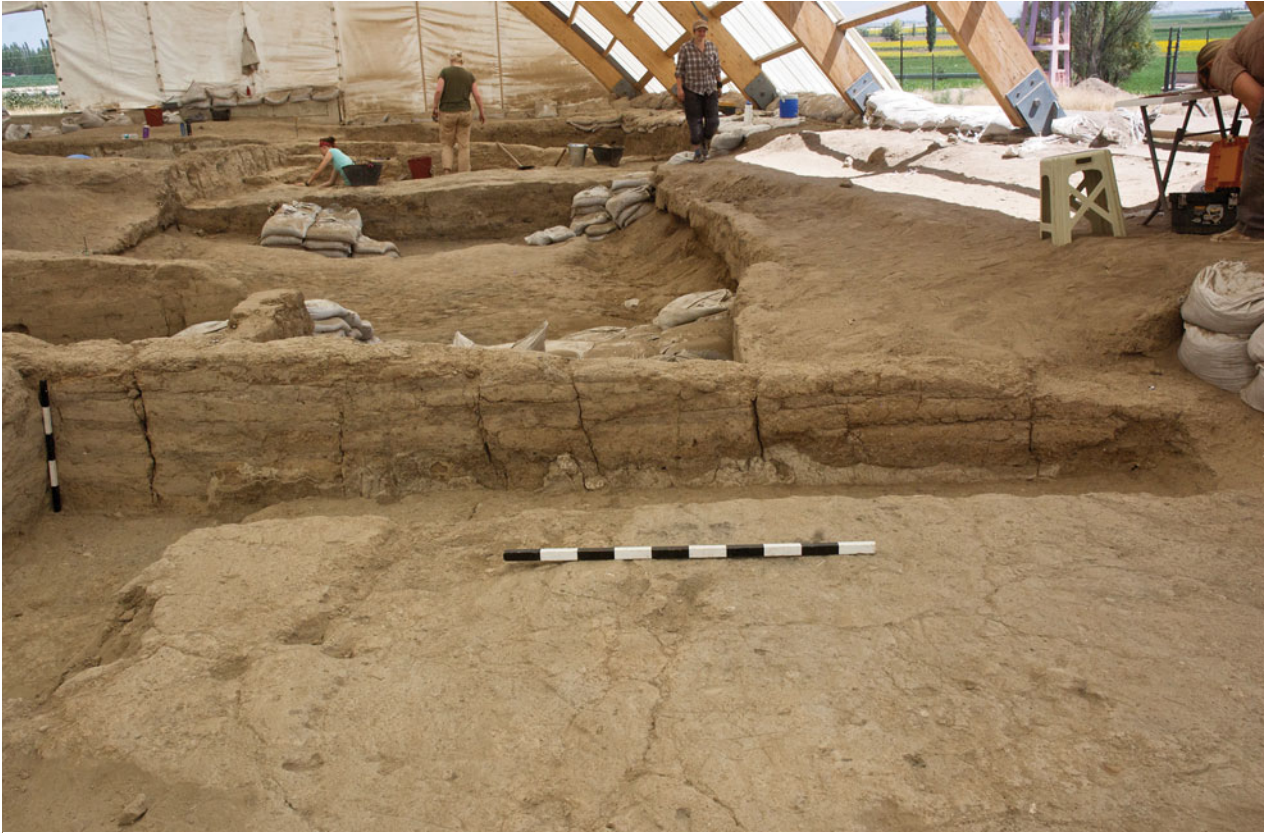
Figure S25.2. North-facing view of northern wall F.7105 (same as F.1021) of Sp.534, B.116. This is an internal wall that was clearly plastered. The constructional trench F.7338 also truncated much of the plaster from the western end of the wall (photograph by Sofie Ekstrand).

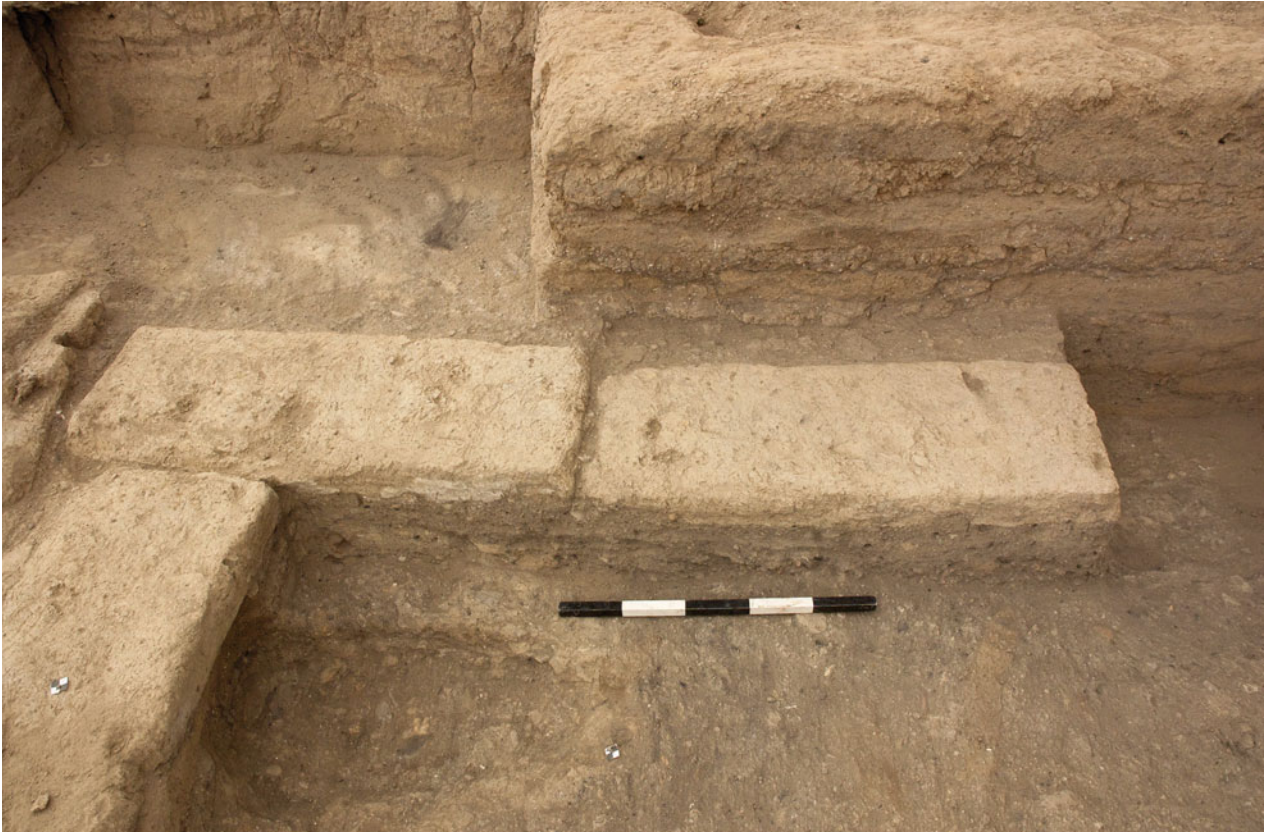
Figure S25.3. South-facing view of the first row of the southern foundation wall F.7341, excavated as (21546). The two bricks lay above (21547), which was the same material as between the southern foundation wall and shoring wall F.7104 immediately to the south (photograph by Maciej Chyleński).

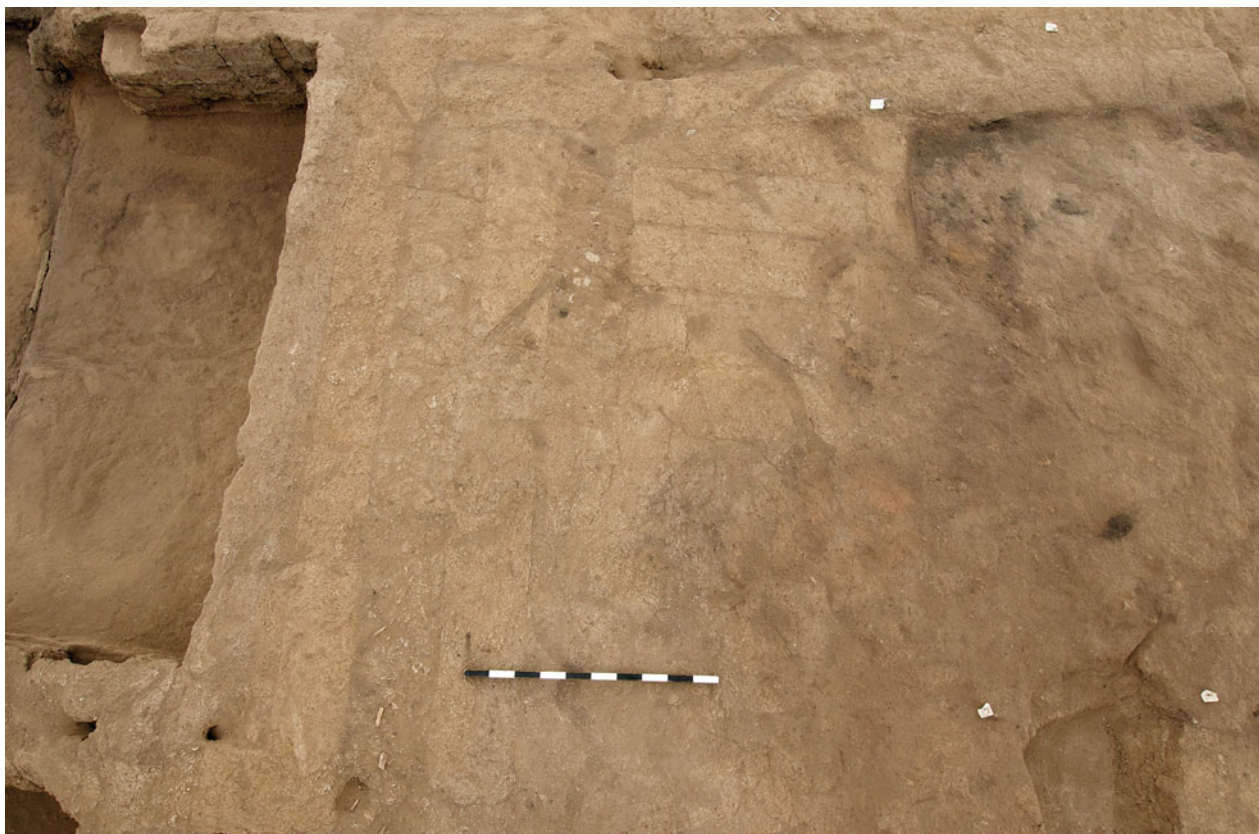
Figure S25.4. West-facing view of platform (20431) (photograph by Jason Quinlan).

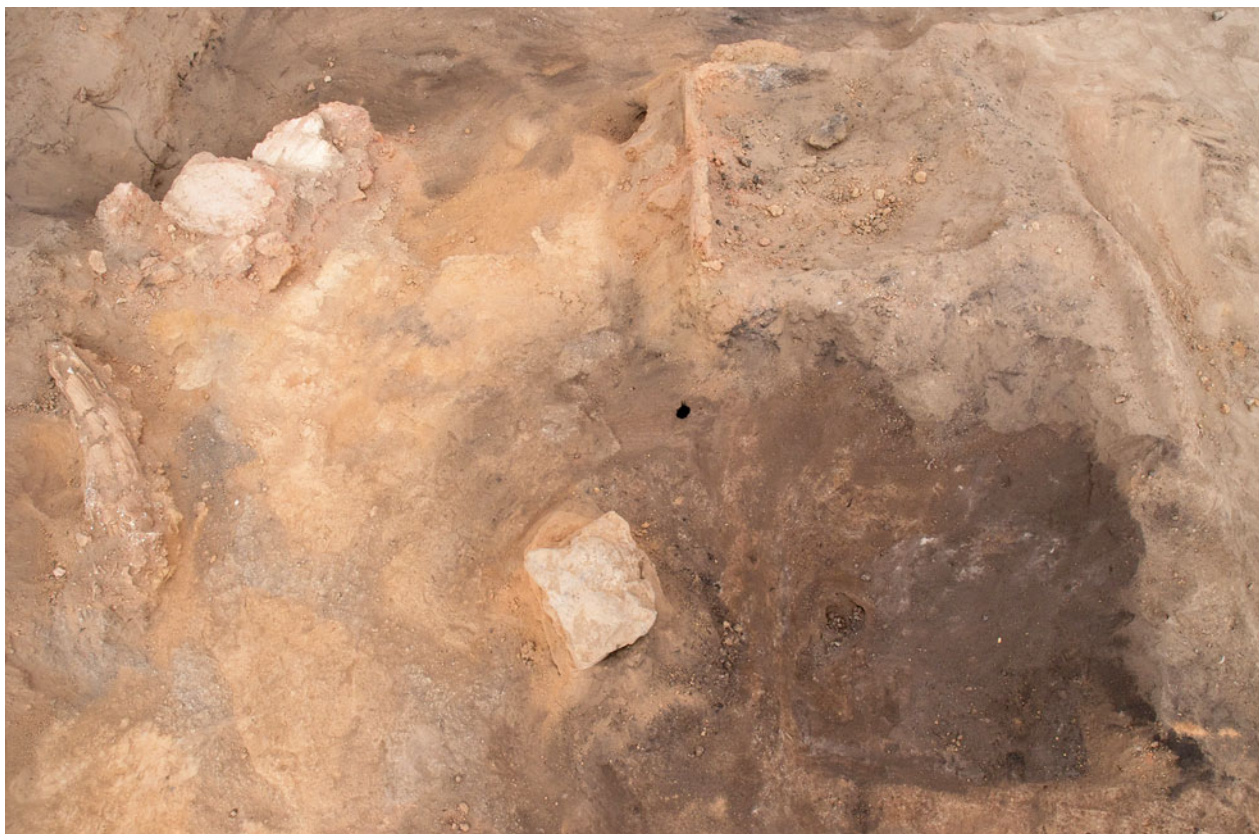
Figure S25.5. Bin F.3649 (photograph by Jason Quinlan).

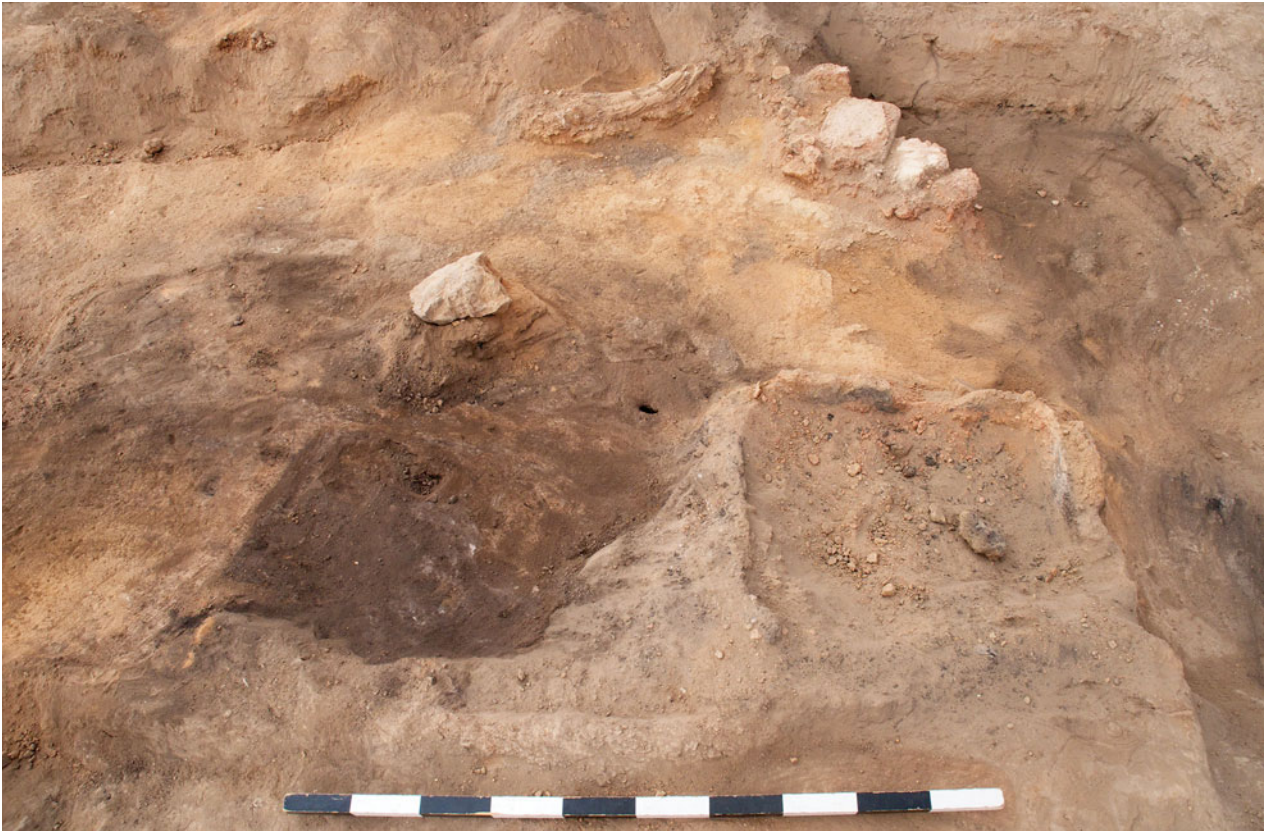
Figure S25.6. South-facing overview of the rubble of Sp.95 by bins F.3649 and F.3650. Horncore 19476.x2 was immediately next to the burnt building materials. In front of the bins is ground stone 19476.x6 (photograph by Jason Quinlan).
